Necessity of Bus Rollover Test

Oct. 17-19, 2017

Kwon Sinwook

(KATRI / Korea)

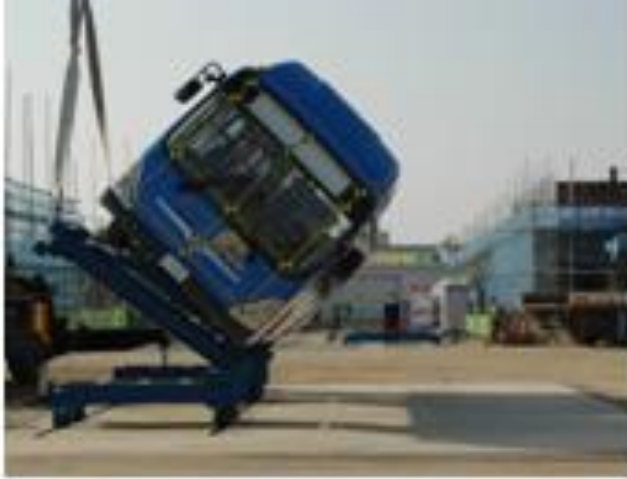
Before

- ❑ Strength of superstructure: Satisfied (Rollover at 40 degree)
- ❑ Analysis of fuel system integrity
 - Gas leakage from broken valves due to the impact
 - Leakage amount by pressure drop in the high pressure portion exceeded the fuel leakage limit of UN GTR 13 (118NL per minute)

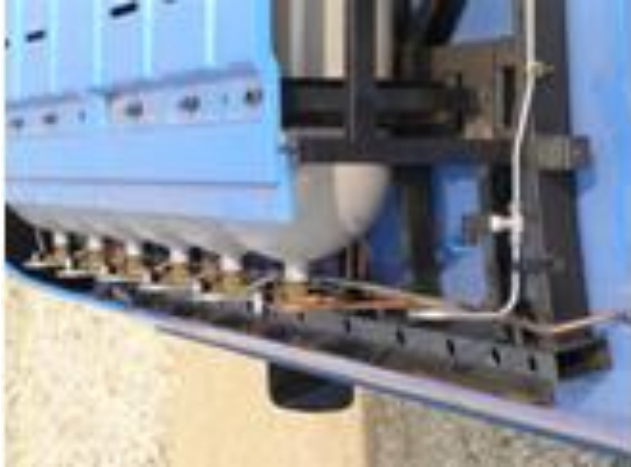
Before

- ❑ Bus rollover test result
 - Mass gas leakage was occurred through the broken valves due to the impact
- ❑ Buses with fuel storages in the roof have possibility of gas leakage after rollover
- ❑ Need to consider bus rollover test in GTR No.13 Ph.2
- ❑ Considerations with test method
 - Body acceleration is very high (more than 40g based on simulation result)
 - Korea is planning to further research on this issue
