CLIENT PROJECT REPORT CPR1825

Pedestrian legform test area assessment

Final report

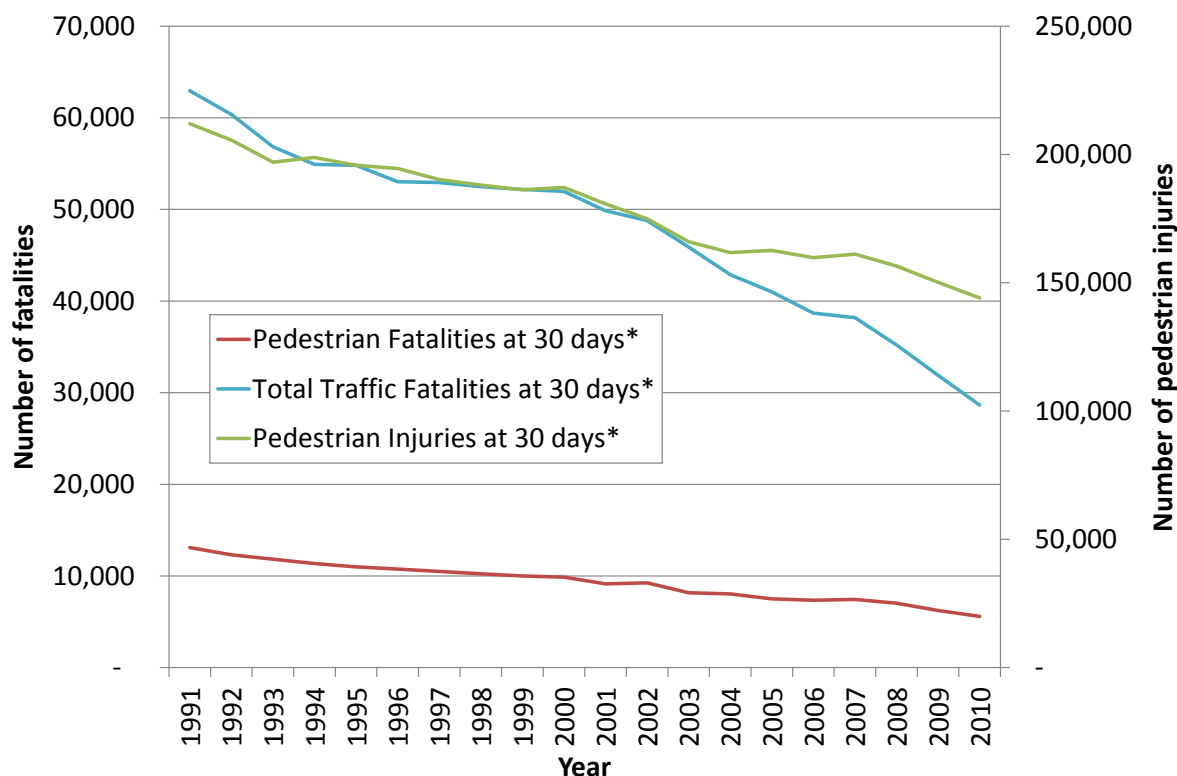
Figure 1-1: Traffic fatalities and pedestrian injuries for twenty year period from 1991 to 2010 (*Where data are missing for a country in a particular year, its contribution to the total is estimated from the next known value)

The number of pedestrians killed or injured within Europe in recent years was determined after interrogation of the CARE accident database. These data are represented graphically in Figure 1-1. From this figure it can be observed that up to 2003, the pedestrian injuries tracked the total number of traffic fatalities closely. Since 2003 the reduction in pedestrian injuries has not been as steep as the reduction in total traffic fatalities. Road safety measures continue to be effective in preventing pedestrian and total traffic fatal accidents, but are perhaps less effective in preventing the occurrence of injuries from pedestrian accidents.

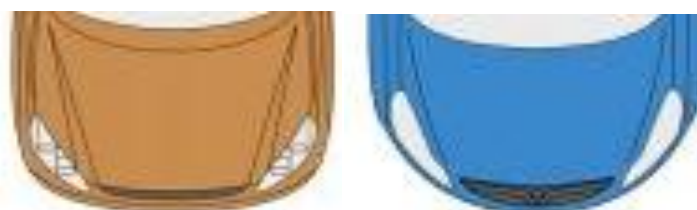
Figure 2-1: Front Bumper profiles of Vauxhall/Opel Corsa C (2000-2006) on the left and Corsa D (2006-Present) on the right.

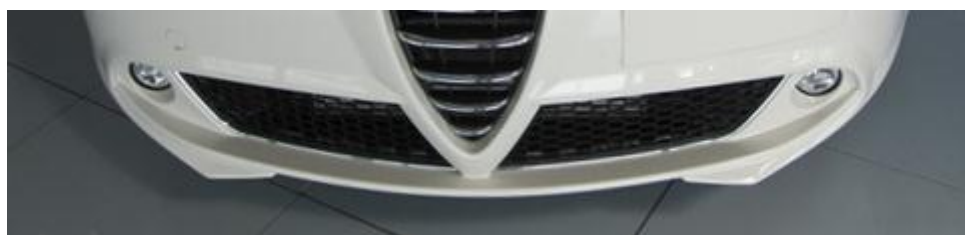
Figure 2-3: Example of a popular supermini car (Alfa Romeo MiTo) displaying additional front bumper designs that affect the definition of the bumper corners.

While Euro NCAP pedestrian ratings include all aspects of the pedestrian testing (including upper legform-to-bumper, headform-to-bonnet and headform-to-windscreen area testing), the legform test allows areas to be excluded that may be difficult to protect. Consequently, these untested areas may be more injurious than the rest of the vehicle's front which would not have been represented in the vehicle's Euro NCAP rating. Furthermore, there is a current trend toward front spoilers with pointed features that exaggerate this effect beyond the curved design of the front bumper (see Figure 2-3). These design changes drastically reduce the testable area of the front bumper to the width between the points of the spoiler.

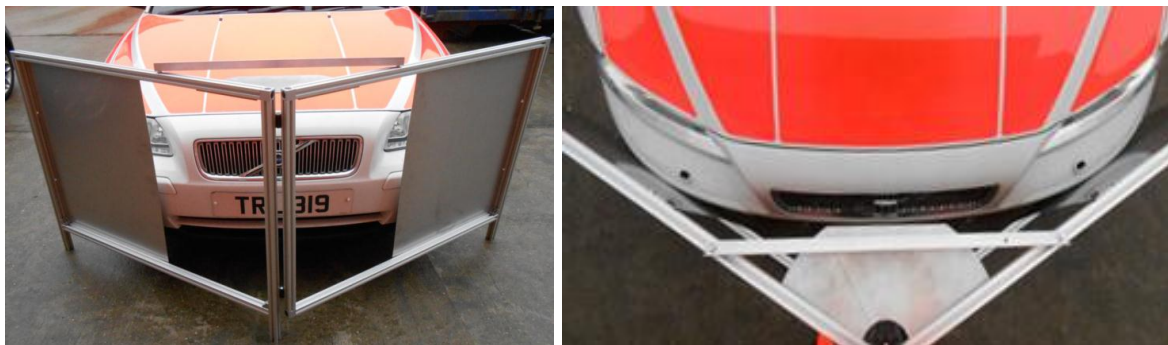
Figure 3-3: Collapsible frame being used to measure the length of the testable area between bumper corners on a Volvo V70.

The frame was set to 120° and aligned with the centre of the vehicle before being moved forwards until contact was made between the bumper corners and planes of the

frame. The distance between the two contact points was then measured using the milled intervals on the gauge. The process was then repeated on the vehicle with the gauge locked at 90° and the distance between the new corners measured. These two bumper corner measurements were then compared to the full width of the vehicle to provide some understanding of how the testable area is influenced by the bumper design.

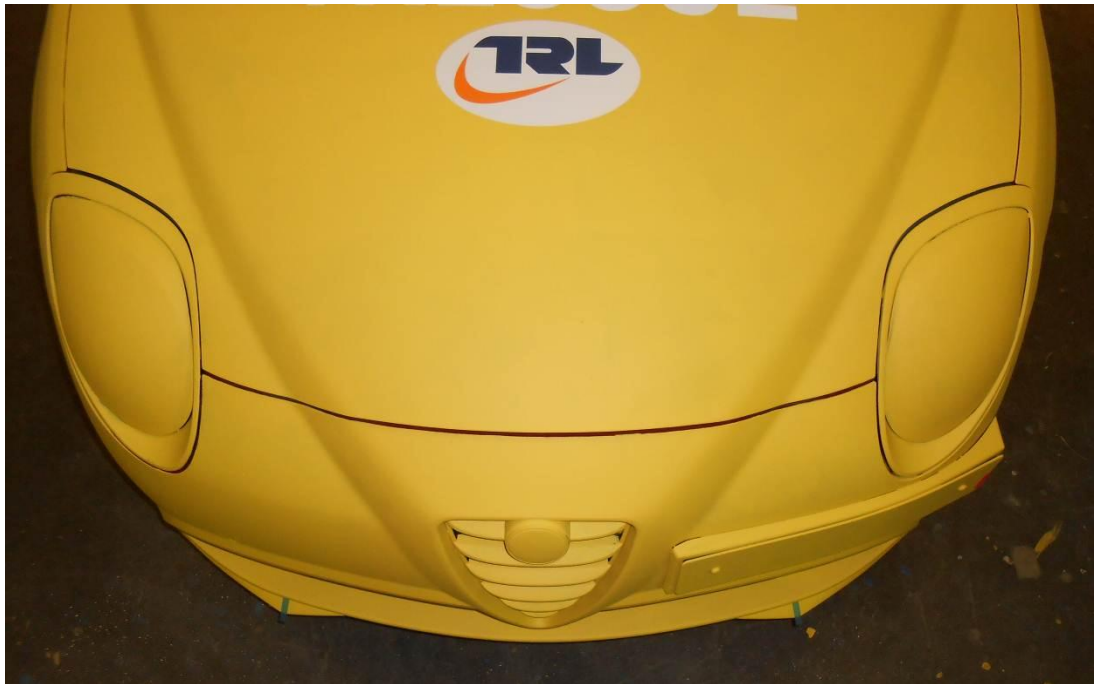
Figure 3-4: Alfa Romeo MiTo after having been measured for this task, showing the location of the 60° bumper corners as marked with green tabs.

The Alfa Romeo MiTo clearly has fangs which fix the position of the 60° plane bumper corners (Figure 3-4). The effect of these fangs is to limit the bumper test area to about 54 percent of the total vehicle width.

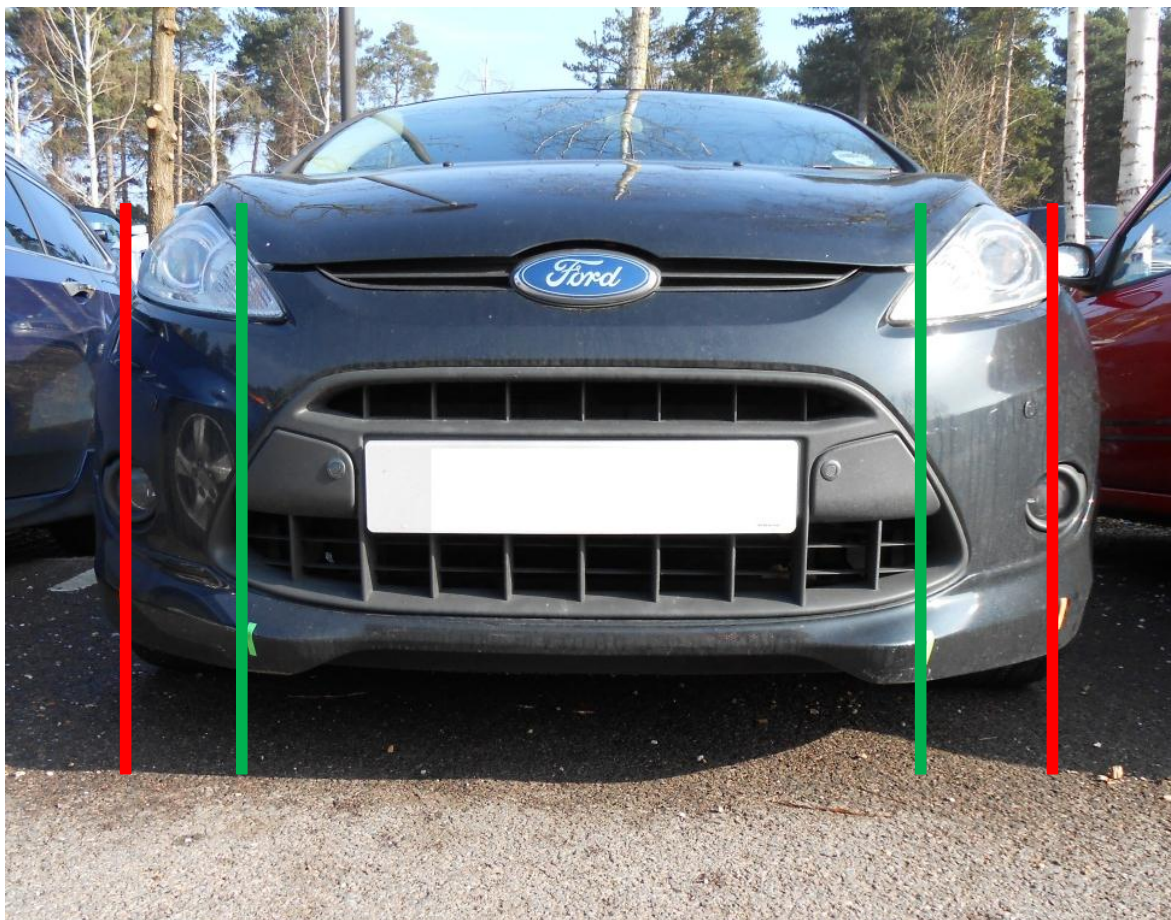
Figure 3-5: Ford Fiesta with the bumper corners shown as determined with a 60° plane (green) and a 45° plane (red).

The initial findings of this task have shown that some new models of vehicle can have a testable area as little as 40% of the full vehicle width when defining the bumper corners with a 60° plane. The Ford Fiesta in Figure 3-5 has a testable area of 46% with corners defined by a 60° plane compared with 75% with corners from a 45° plane.

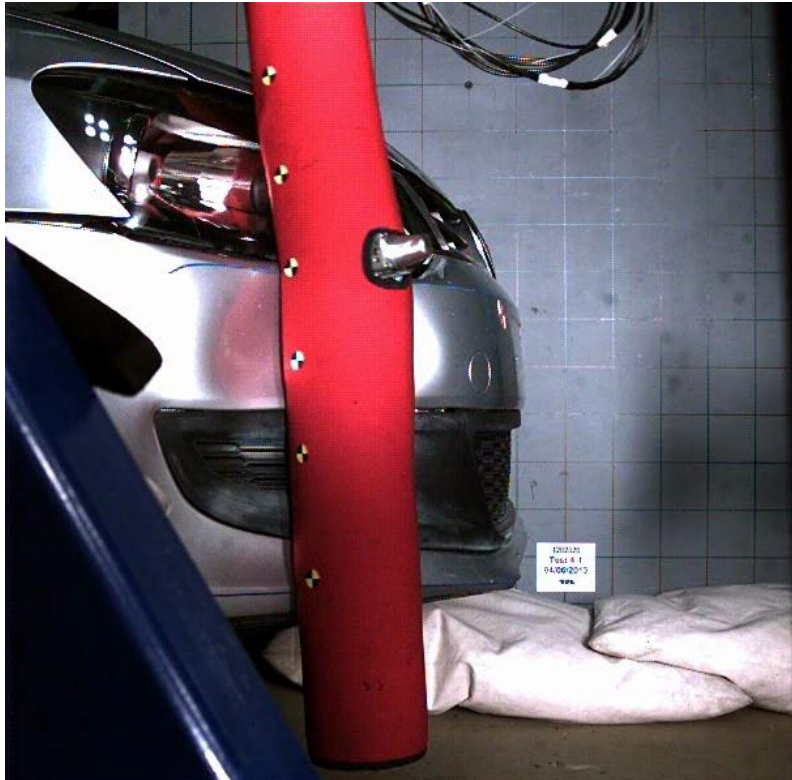
Figure 3-7: Volkswagen Polo during testing of the bumper corner defined by the 45° plane.

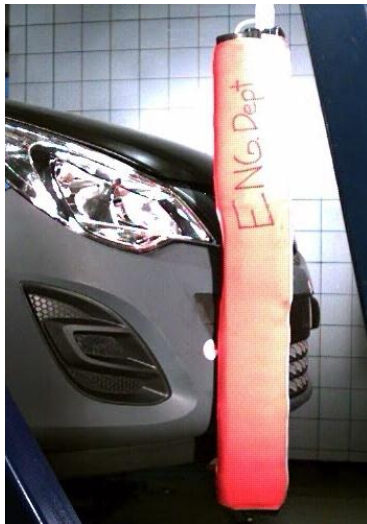
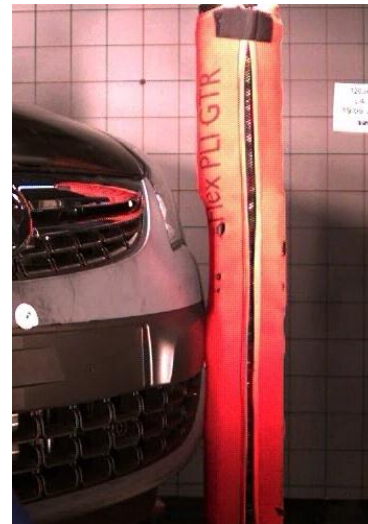
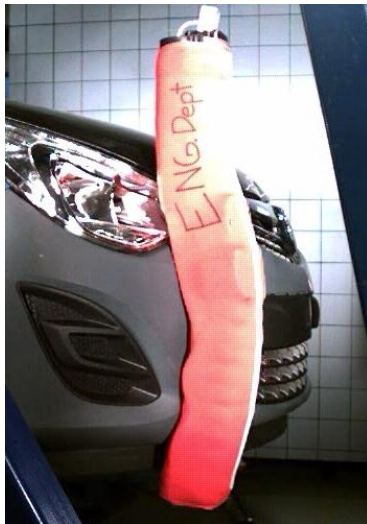
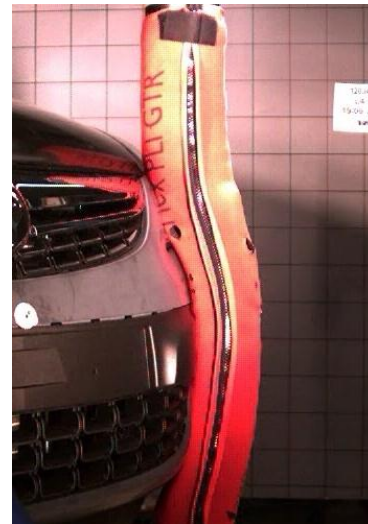
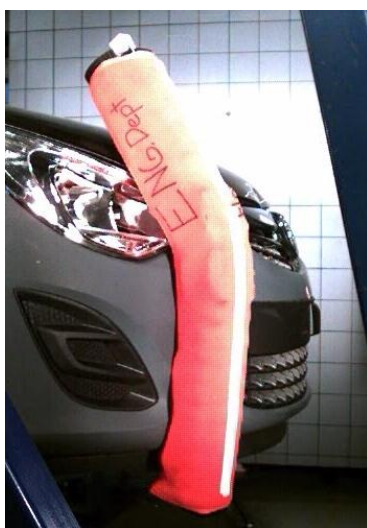
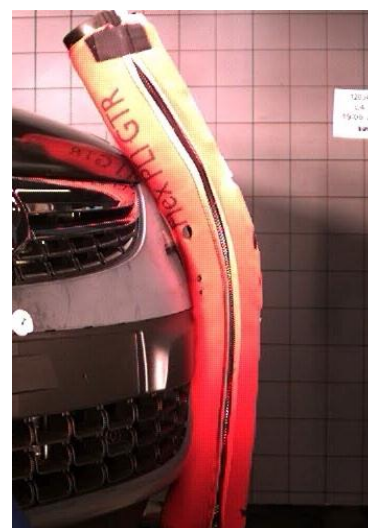
At impact time, $t = 0$ ms

At time $t = 10$ ms

At time $t = 20$ ms

Figure 3-9: Motion of Flex-PLI during tests to end of bumper beam of Vauxhall Corsa: longitudinal test (Test 2) on left, normal test (test 3) on right

As an example of the results obtained from this testing, time histories of the data are shown in Figure 3-8, for the longitudinal test to the end of the bumper beam (Test 2) of Vehicle 3. The lower graph includes the Lateral Collateral Ligament (LCL) elongation, for which no injury criterion is specified. As already noted, rotation angles were obtained only for the specific times at which peak values were obtained, so no time histories are available for Flex-PLI rotation. However, in order to show the rotation visually, frames have been extracted from the test videos for the two tests to the bumper beam (Tests 2 and 3) of the Vauxhall Corsa; see Figure 3-9.

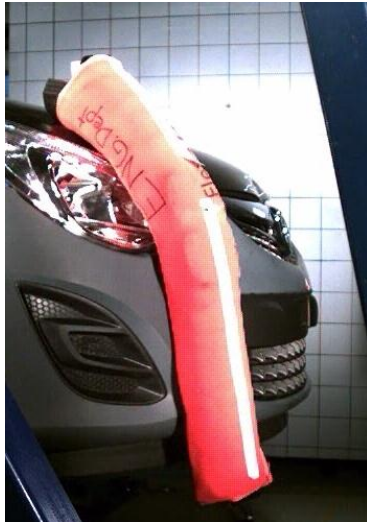
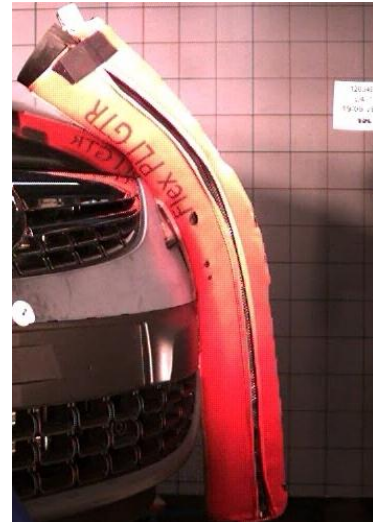
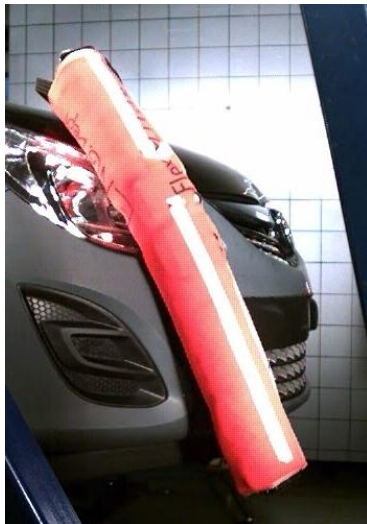
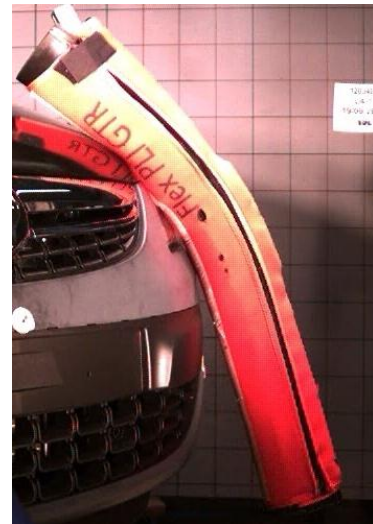
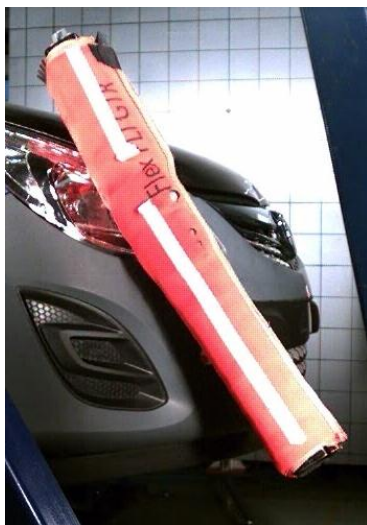
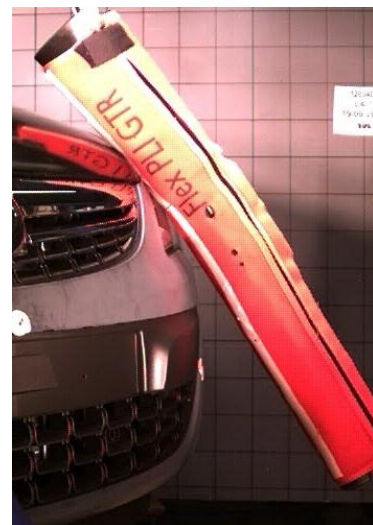
At time $t = 30$ ms

At time $t = 40$ ms

At time $t = 50$ ms

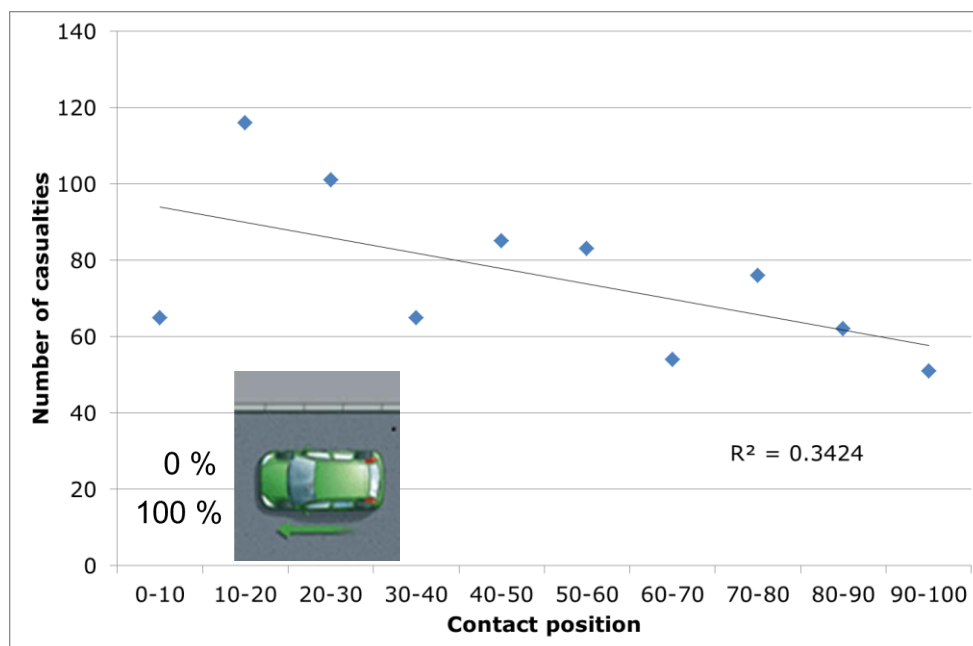
Figure 4-6: Distribution of casualties across contact points of the bumper (GIDAS)

Figure 4-6 shows that more pedestrian casualties were struck by the nearside of the vehicle than those struck by the offside. The regression line shows that the contact position only explains 34% of the variability in the number of casualties.

Figure 4-5 shows the distribution of casualties across contact points of the bumper in the OTS sample; a line of best fit is included. Figure 4-6 shows the equivalent data from the GIDAS sample. The R^2 value (a measure of the variance explained by the model) is also shown.

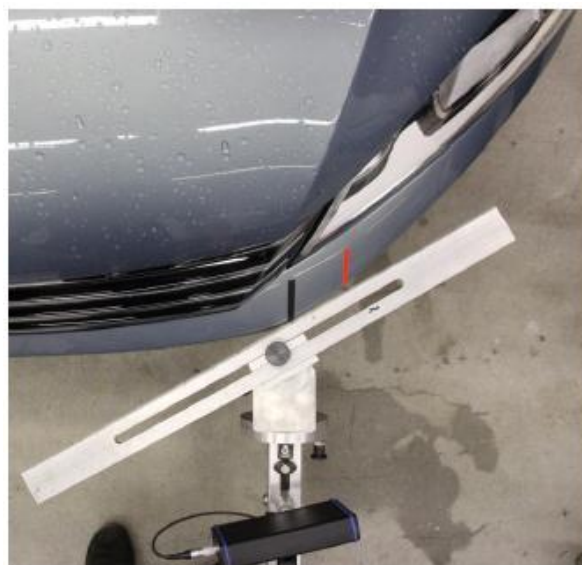
Figure 6-2: Bumper corner according to Option 5

30 degree plate at bumper height
(in the range 350 to 550 mm)

Indeed an example was readily found for a European current high-volume vehicle which has a bumper beam which extends beyond the corners, as would be defined with Option 5. In this case (Figures 6-1 and 6-2) the difference between the bumper beam width and the proposed impact zone was approximately 140 mm. This shows how this change in definition for the bumper corner will not include the hard structures around the end of the bumper beam for all vehicles. As such it may not offer a means of obtaining the full benefit identified within this report (in Section 4.5).
