Ford GTR09 US Vehicle Round Robin

March 19th, 2013

Ford Round Robin:

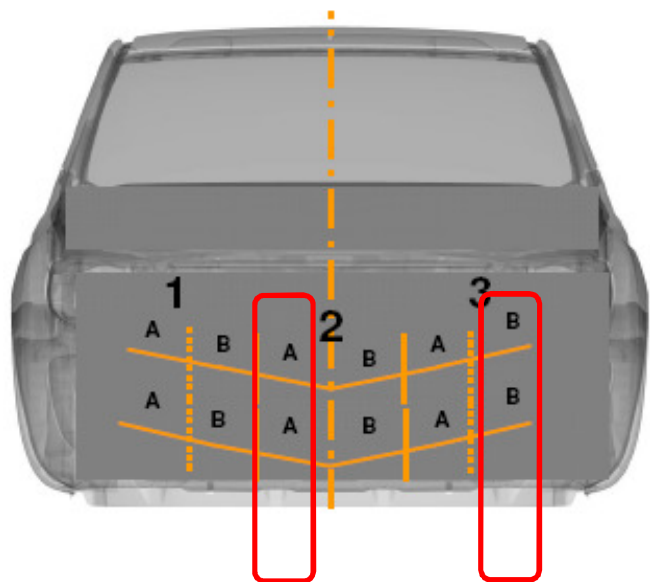
Ford - Test Set-up and Plan:

- Mid-size truck/utility vehicle
- Bumper Lower Reference Line (BLRL)
350–485mm
- Bumper / fascia design similarly to sedan approach

- Near middle (2A)
- Aligned with headlamps (3B)

- Evaluation of repeatability and reproducibility to further understand the potential feasibility issues associated with mid-size truck/utility vehicles
 - Due to part availability and limited test time the objectives were adjusted to assess the influence of ride height

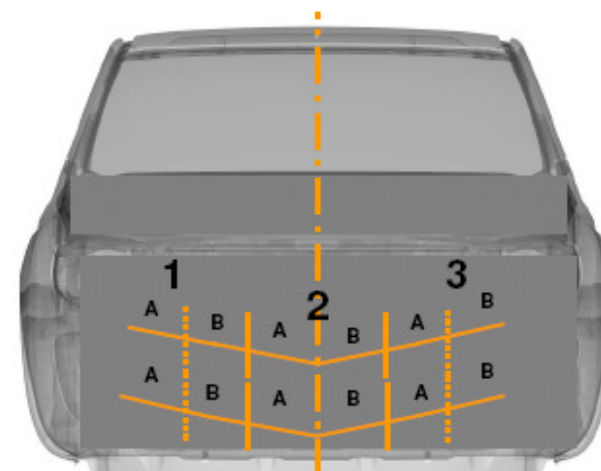
Ford - Test Results (Center Location):

Test Number	Location	Tibia 1 Nm	Tibia 2 Nm	Tibia 3 Nm	Tibia 4 Nm	ACL mm	MCL mm	PCL mm	Ride Height
GTR Proposed Criteria		340	340	340	340	13	22	13	
Test 1 (SN01)	2A	216	357	293	144	2.5	1.8	2.6	Low – 50 mm
Test 3 (SN01)	2B	325	370	272	100	5.9	7.1	2.4	Mid
Test 5 (SN01)	2B	339	297	187	72	10.5	19.7	6.1	High - 50 mm
Test 6 (E-leg)	2A	Data did not record

- MCL, PCL and ACL tend to increase with increasing ride height
- Tibia numbers did not show a trend

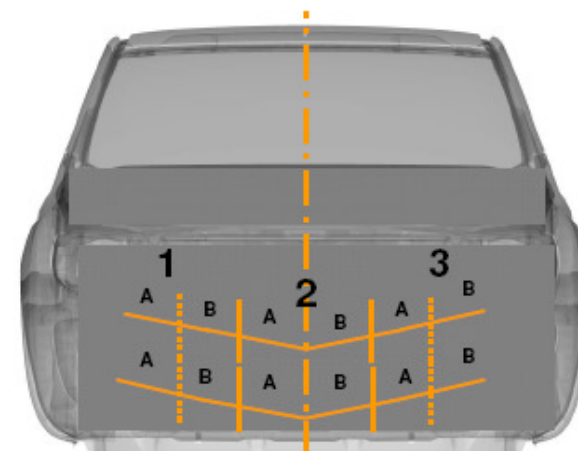
Ford - Test Results (Outside Location):

Test Number	Location	Tibia 1 Nm	Tibia 2 Nm	Tibia 3 Nm	Tibia 4 Nm	ACL mm	MCL mm	PCL mm	Ride Height
GTR Proposed Criteria		340	340	340	340	13	22	13	
Test 2 (SN01)	3B	153	138	112	63	4.4	7.8	2	Mid
Test 7 (E-leg)	3B	148	136	106	52	6.4	9.9	3	Mid
Test 4 (SN01)	1A	340	320	233	106	9.4	16.3	7.2	High - 50 mm

- Similar to the center location, the measurements increased with increasing ride height
- Comparable results between SN01 (test 2) and E-Leg (test 5).
