TF-BTA-3-06

Task Force – Bumper Test Area: EC study update

Presented by Jolyon Carroll Senior Researcher – 18 March 2013

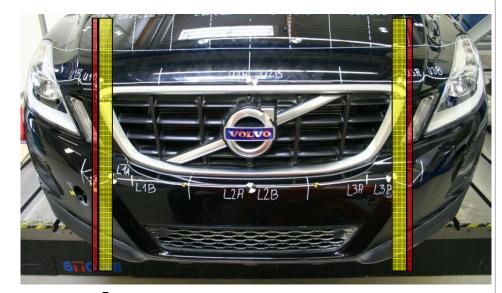
- TWG identified the Volvo V60 for monitoring
- Tested 2 points outside of conventional areas
 - "S2" On the bumper corner (disregarding the 66mm margin)
 - "S1" Outside the bumper corner near the tow-eye
 - 3 parameters used to assess test point performance
 - Tibial acceleration (g)
 - Knee shear displacement (mm)
 - Knee bending angle (°)

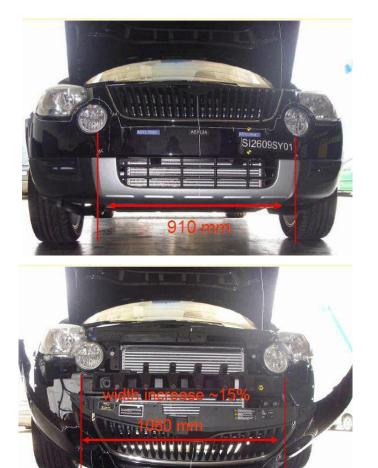
Bumper Removal

- Euro NCAP began removing the bumper panels to reveal the underlying structures
- Applied 60° plane to underlying structures (i.e. bumper bar)
- Had the general effect of increasing the bumper width
- Structures outside of the bumper bar that were still identified as potentially injurious
- But there are experimental difficulties in testing these outboard structures

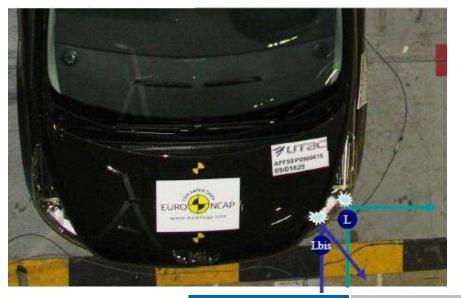
Experimental difficulties

Normal test zones		Monitored test zones		
	L1A	L2A	L3B	L3bis	L3out
Knee bending angle - deg	9.43	3.55	9.43	0.3	0.11
Knee Shear Displacement - mm	2.24	2.69	2.24	1.49	1.57
Tibial acceleration - g	109.6	108.1	109.6	50.2	70

Oblique surfaces

- Monitoring highlighted experimnetal difficulties when testing structures outside of bumper corners
- Surfaces tend to be at oblique angles
- Inconsistencies were recorded in all parameters
- The decision was made to limit testing to within the edges of the bumpar bar to prevent experimental discrepancies
