PEDESTRIAN PROTECTION

Assessment on vehicle tested with
Lower Legform at
limits of BTA and beyond

Lower Leg Impact

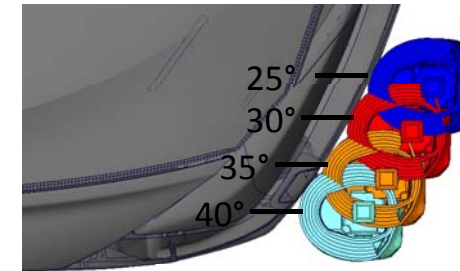
I. Impact Locations

Colour	Y-coordinate	Angle [°]	
dark blue	628	25	Test approx. at outer border of BTA (= COB -66 mm)
red	690	30	Test at COB
orange	756	35	
Light blue	802	40

angle of vertical plane touching at given Y-coordinate to vertical transversal plane

BTA = Bumper Test Area
COB = Corner of Bumper

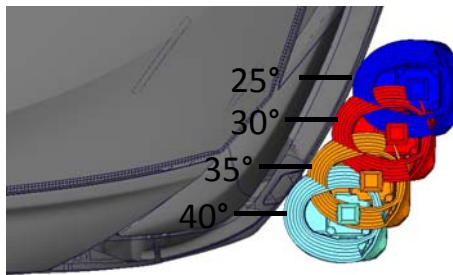
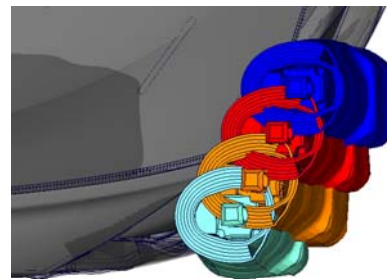
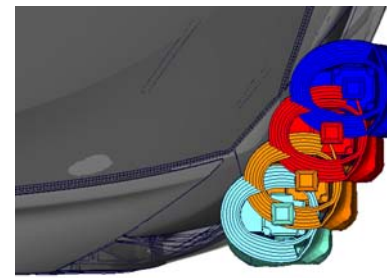
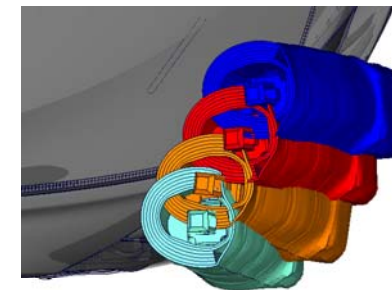
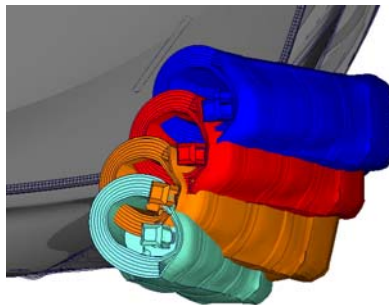
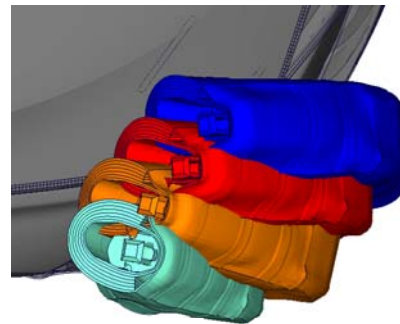
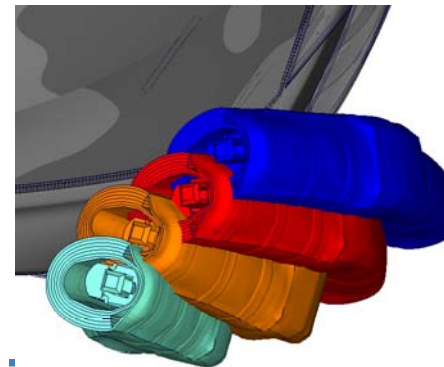
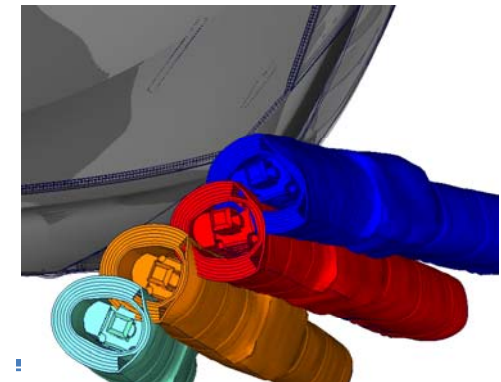
II. Vehicle impacted by Flex Pli – in top down view

0ms

10ms

15ms

20ms

25ms

30ms

40ms

50ms

- Increasing impactor rotation at more outboard impact locations
- Increasing lateral motion at more outboard impact locations; rebound transforms to sidewise sliding or deflection motion

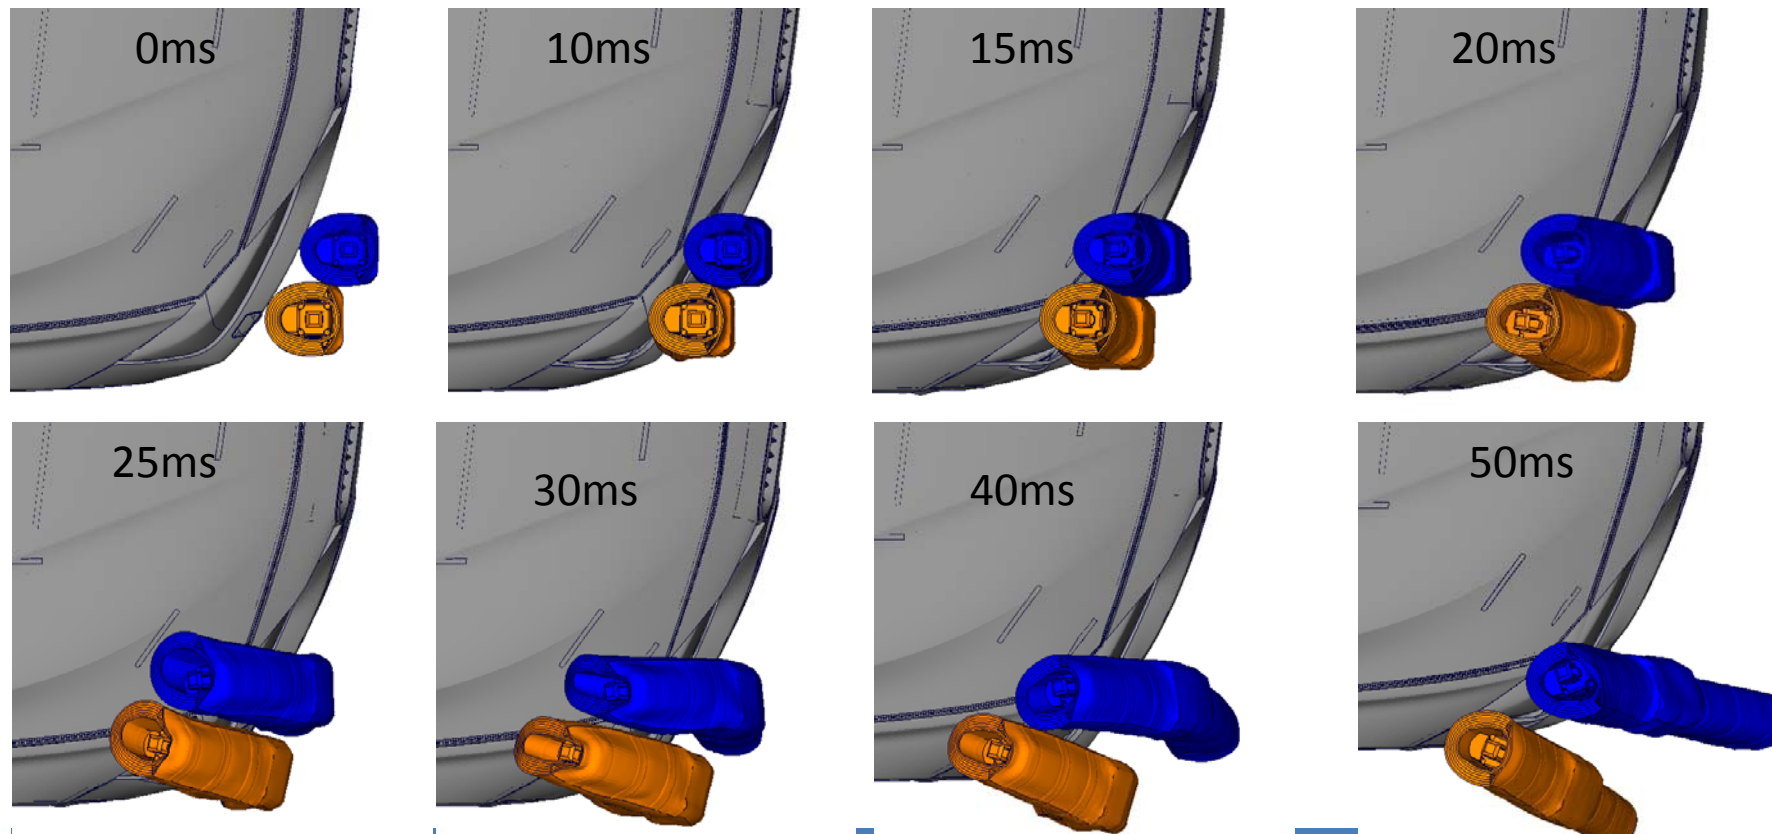
II. Vehicle impacted by Flex Pli Impactor in top down view

$Y = 628, \alpha = 25^\circ$ / $Y = 756, \alpha = 35^\circ$

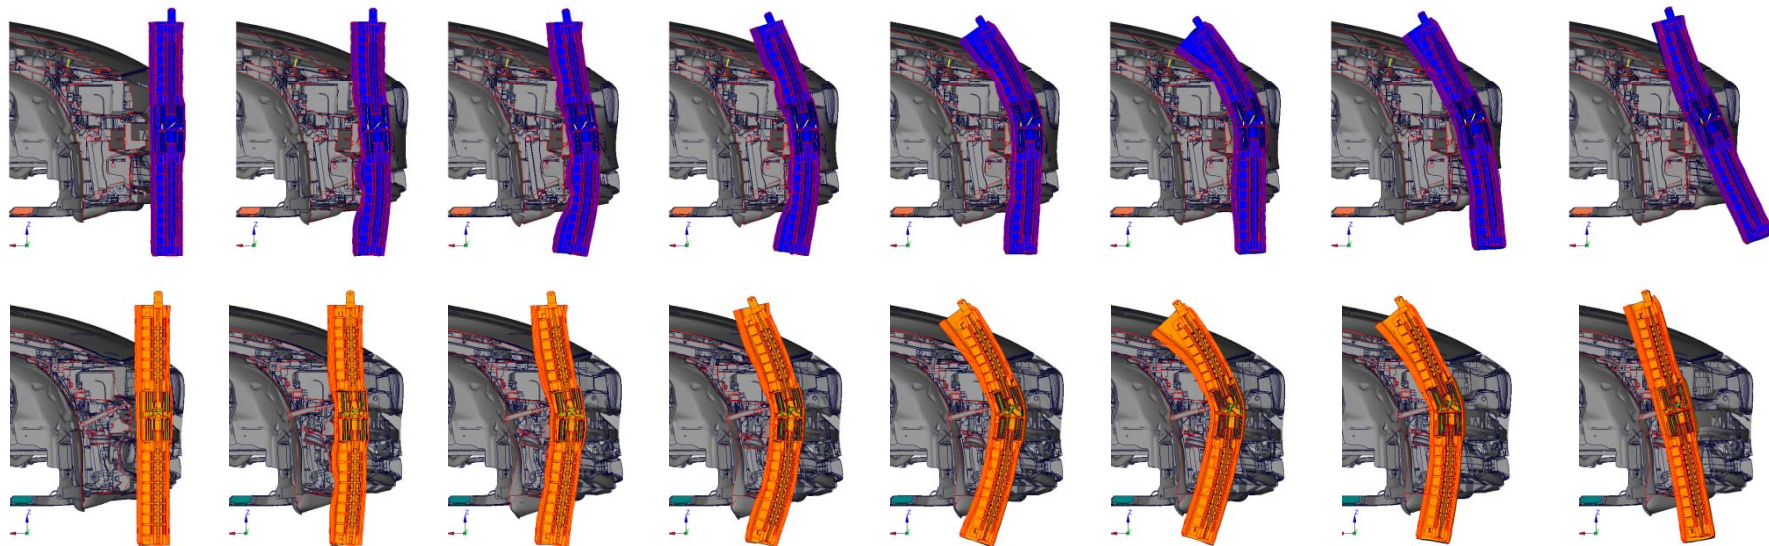
II. Vehicle impacted by Flex PLI Impactor in top down view

$Y = 628, \alpha = 25^\circ$ / $Y = 756, \alpha = 35^\circ$

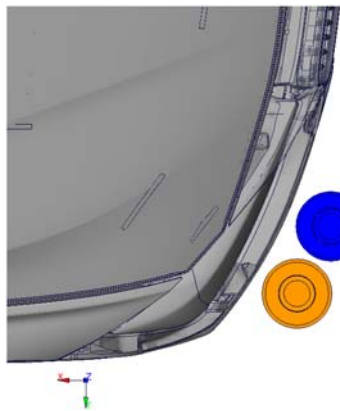
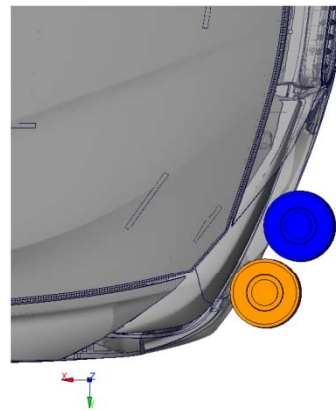
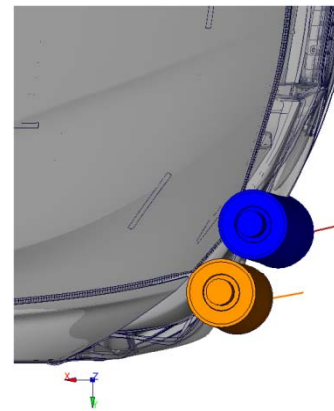
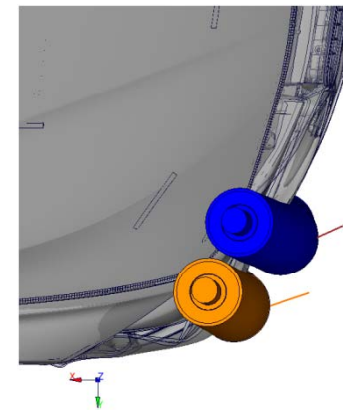
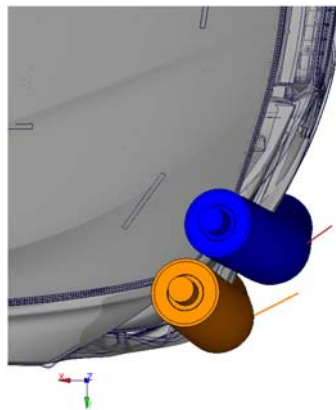
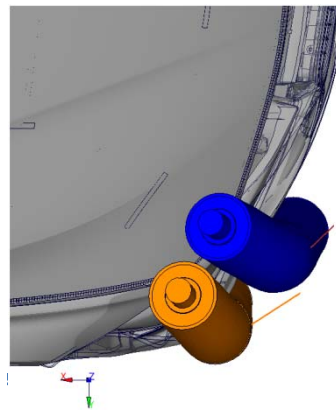
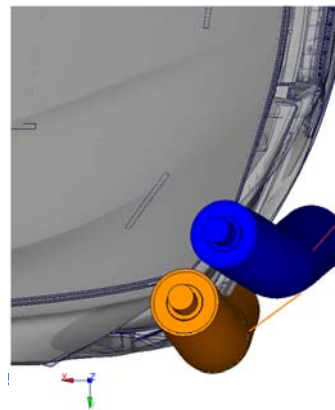
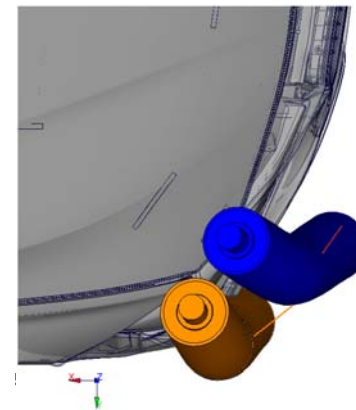
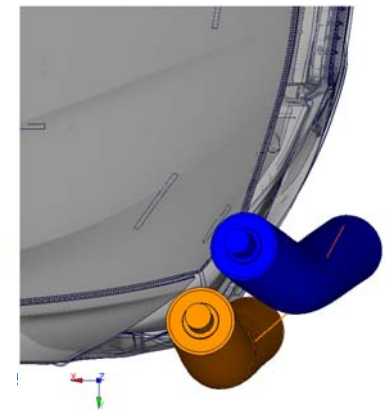
III. Vehicle impacted by EEVC Legform impactor in top down view

$Y = 628, \alpha = 25^\circ$ / $Y = 756, \alpha = 35^\circ$

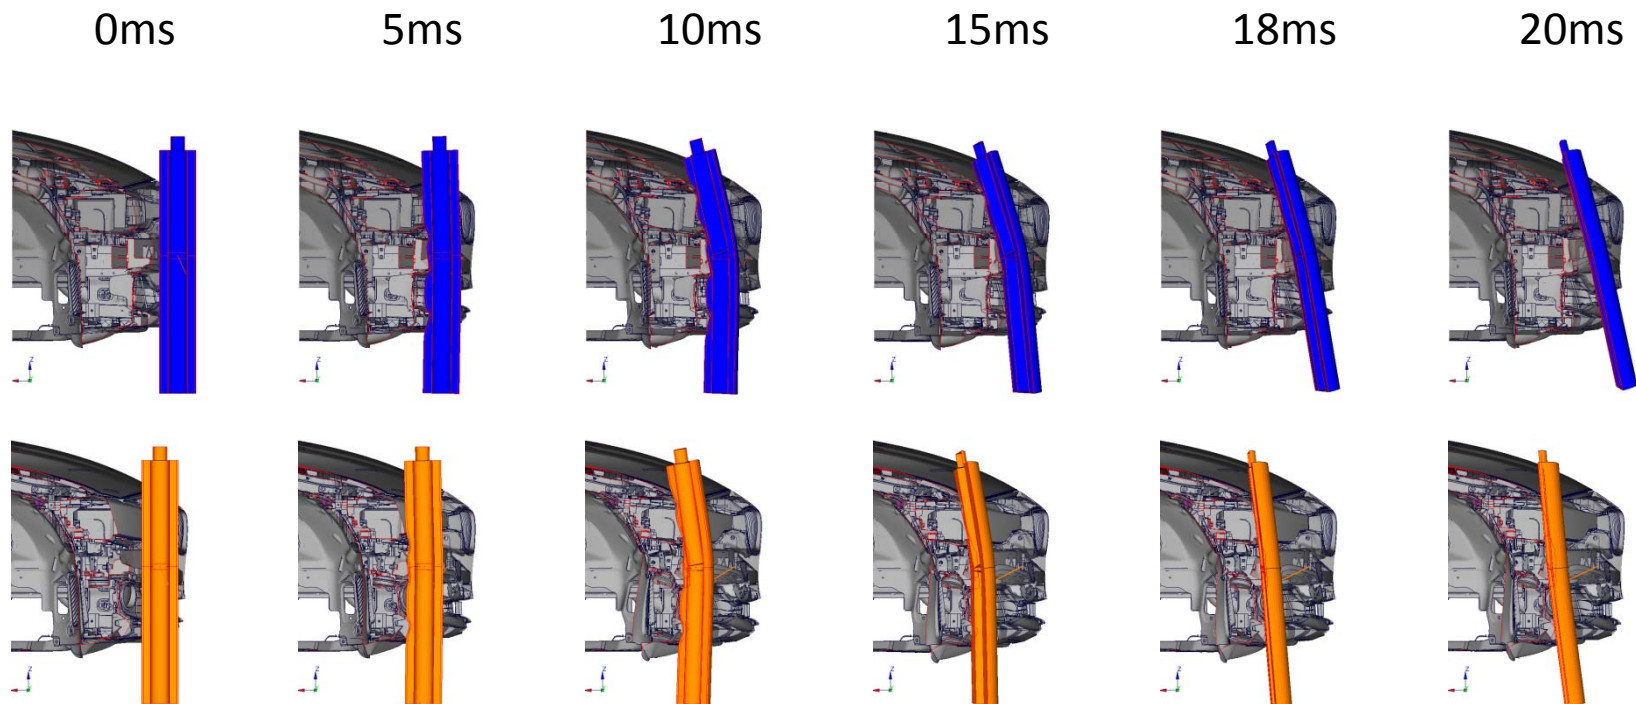
III. Vehicle impacted by EEVC legform impactor in top down view

$Y = 628, \alpha = 25^\circ$ / $Y = 756, \alpha = 35^\circ$
