Experimental study of tenability during a full-scale motorcoach tire fire

Erik L. Johnsson | Jiann C. Yang

Engineering Laboratory, National Institute of Standards and Technology, Gaithersburg, Maryland

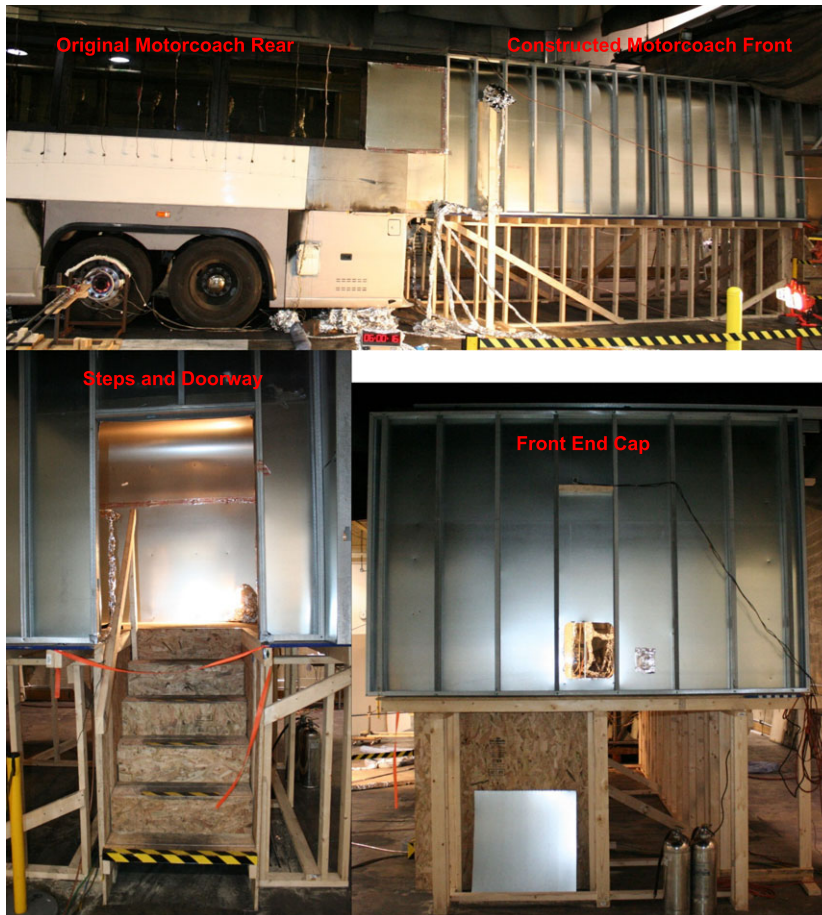
FIGURE 1 Photographs of the motorcoach extension. The top photo shows most of the assembly of the original motorcoach rear half and added front extension. The bottom left photo shows the extension doorway and steps. The bottom right photo shows the front end with the window and visibility camera [Colour figure can be viewed at wileyonlinelibrary.com]

The constructed front of the motorcoach, shown in Figure 1, consisted of a wood frame structure supporting a plywood deck upon which a steel stud frame was built and to which a galvanized sheet steel interior skin was attached. The front-end cap had access holes cut into it for a glass observation window and camera access. A doorway approximately matched that of an MCI* E-series coach. Stairs

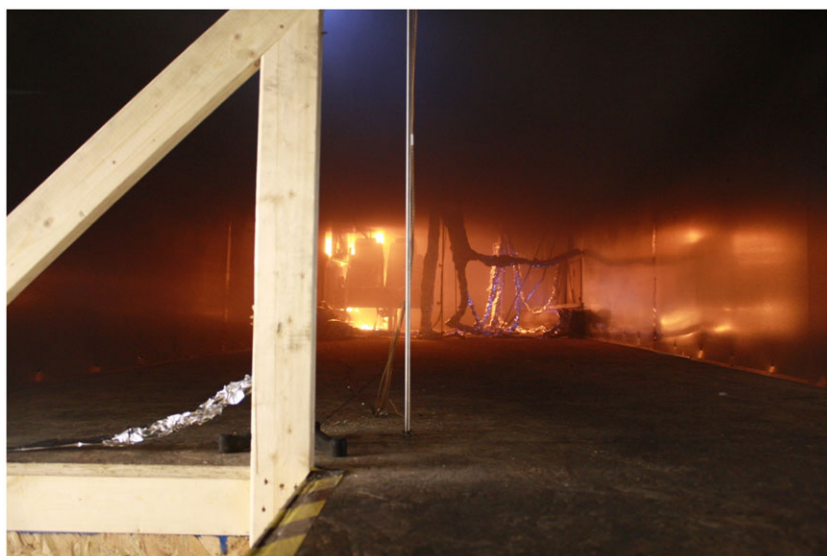
FIGURE 8 Tenability experiment passenger compartment about 15 minutes after burner removal [Colour figure can be viewed at wileyonlinelibrary.com]

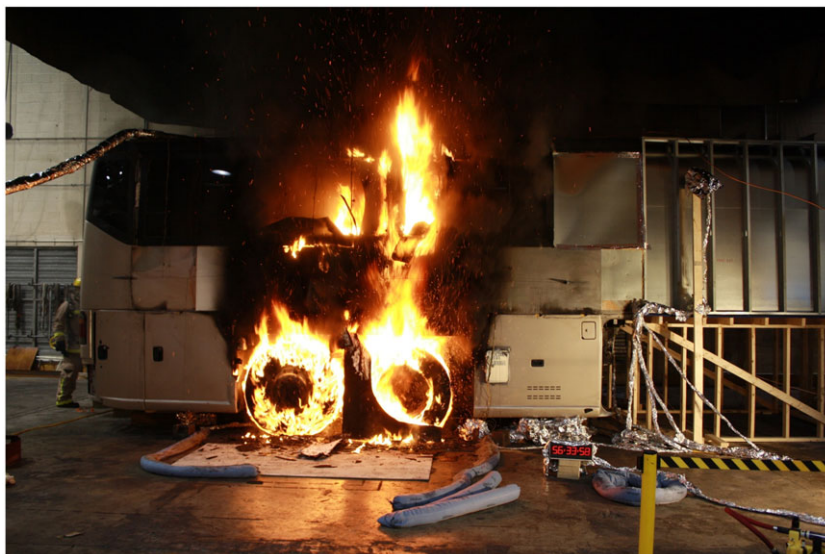
FIGURE 9 Tenability experiment almost 20 minutes after burner removal [Colour figure can be viewed at wileyonlinelibrary.com]

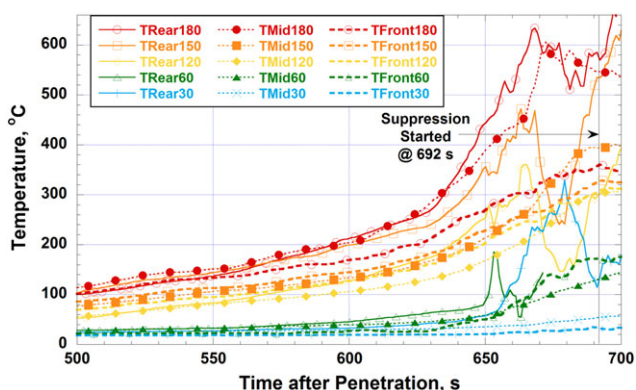
FIGURE 10 A plot of interior rear, middle, and front gas temperatures versus time after penetration. Numbers 30 through 180 represent distance from the floor in centimeters [Colour figure can be viewed at wileyonlinelibrary.com]

Figure 10 shows the thermocouple array temperatures plotted versus time after fire penetration for the 3 minutes before suppression. By 100 seconds prior to suppression, all the temperatures at or above 1.2 m from the floor exceeded 100°C. The thermocouples at 30 cm from the floor at the middle and front arrays had maximum temperatures of 54°C and 34°C, respectively, before extinguishment. The

60-cm height middle and front maximum temperatures were 133°C and 172°C, respectively. These peaks occurred at or within several seconds of extinguishment. This indicates that even the most tenable location, near the floor, was becoming untenable at the end of the experiment.

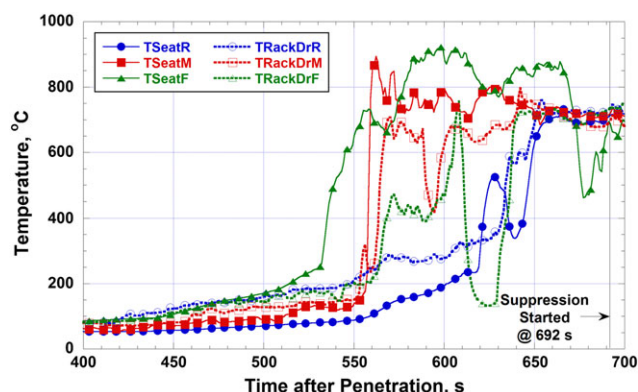
FIGURE 11 Seat headrest and parcel rack door temperatures plotted versus time after penetration. Locations were on or over the rear (R), middle (M), and front (F) seats [Colour figure can be viewed at wileyonlinelibrary.com]

The temperatures of the tops of the aisle seat headrests and the parcel rack doors above them were measured with thermocouples (see locations in Figures 2–4). Figure 11 shows a plot of these temperatures versus time after fire penetration of the passenger compartment. Each pair of headrest and door temperatures tracked somewhat with each other, which indicates that the thermal environment varied more with the axis of the motorcoach and not as much vertically at each row. The front seat seems to have been involved in the fire first followed by the middle and then rear. The front and middle parcel rack door temperatures lagged their matching headrest temperatures indicating that they were receiving heat from the

flaming seats but may not have been as involved in the fire as the seats. At the rear headrest, this was reversed indicating that the parcel rack door was being heated more by the burning of the middle and front seats than the rear seat. At about 620 seconds after penetration, the rear seat appears to ignite, and the seat and door temperatures rose rapidly.

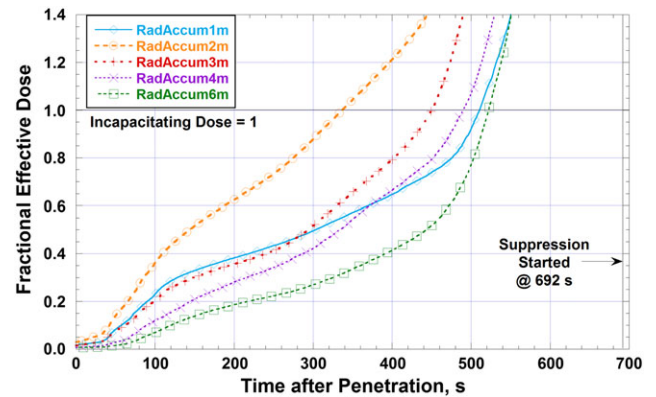
FIGURE 13 Fractional effective doses from thermal radiation plotted versus time after penetration for the six heat flux gauges located 1, 2, 3, 4, and 6 m from the rear (lavatory door) of the motorcoach [Colour figure can be viewed at [wileyonlinelibrary.com](#)]

The reciprocal of t_{rad} is the FED for radiant heat. Figure 13 is a plot of the FEDs for the five total heat flux gauges plotted versus time after penetration. The FED value of 1 reflects the tenability threshold. According to this analysis, the times after penetration for untenable conditions (in increasing order) were 337 seconds for the 2-m gauge, 450 seconds for 3 m, 490 seconds for 4 m, 511 seconds for 1 m, and 522 seconds for 6 m. Therefore, because of thermal radiation alone, the rear half of the motorcoach started to become untenable 5 minutes

37 seconds after penetration and became completely untenable within 9 minutes.

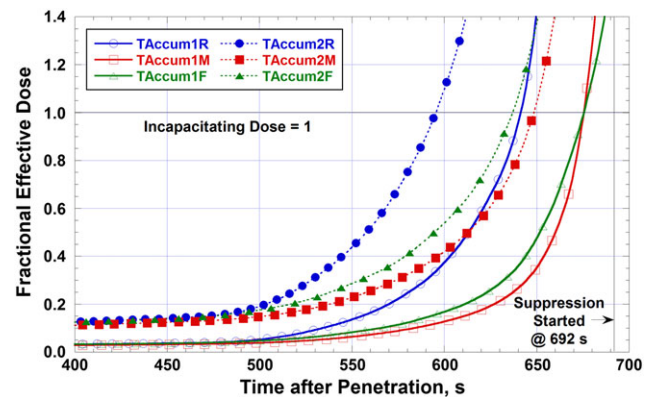
FIGURE 14 Fractional effective doses from thermal convection plotted versus time after penetration for the thermocouples 1.5 m from the floor at the rear (R), middle (M), and front (F) thermocouple arrays. The type 1 analysis treats occupants as fully clothed while type 2 is for more lightly clothed occupants with more skin exposure [Colour figure can be viewed at [wileyonlinelibrary.com](#)]

Figure 14 is a plot of the FEDs for thermal convection plotted versus time after penetration. The FED value of 1 reflects the tenability threshold. According to this analysis, the times after penetration for untenable conditions for fully clothed passengers would be 641 seconds at the rear station, 675 seconds at the middle, and 676 seconds at the front. For lightly clothed passengers, the times would be 595 seconds at the rear station, 648 seconds at the middle, and

637 seconds at the front. From these times, the rear of the motorcoach became untenable 10 minutes 41 seconds after penetration for fully clothed persons and 9 minutes 55 seconds for lightly clothed persons. For the middle station, the times from penetration were 11 minutes 15 seconds and 10 minutes 48 seconds, and for the front, the times were 11 minutes 16 seconds and 10 minutes 37 seconds. In summary, from thermal convection alone and for any clothing type, the motorcoach began to be untenable in the rear just under 10 minutes after penetration and the whole motorcoach became untenable by 11 minutes 16 seconds.

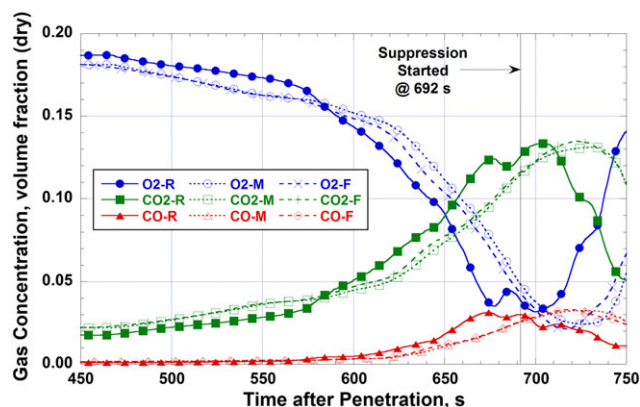
FIGURE 16 O_2 , CO_2 , and CO volume fractions measured at the rear (R), middle (M), and front (F) sampling locations plotted versus time after penetration [Colour figure can be viewed at wileyonlinelibrary.com]

O_2 decreased all three locations from near ambient levels over 20% to about 19% by 110 seconds after fire penetration. From 110 to 460 seconds, O_2 decreased slowly to about 18% before beginning a more rapid decrease to 4% (rear), 4.5% (front), and 5% (middle) when extinguishment was initiated at 692 seconds after penetration. On the same plot, CO_2 increased at all three locations from ambient to about 1.5% by 110 seconds. From 110 to 460 seconds, CO_2 rose slowly to about 2% before beginning a more rapid rise to 12.5% (rear) and 11.5% (middle and front) when extinguishment was initiated at 692 seconds. Also shown in Figure 16, CO increased at all three locations from 0% to about 0.1% and stayed below 0.2% until about 510 seconds. After 510 seconds, CO rose more rapidly. CO in the rear peaked at 3.1% and decreased slightly to 3.0% at 692 seconds when extinguishment was initiated. The middle and front CO volume fractions lagged the rear position and were only about 2.6% at the beginning of extinguishment. The extinguishment process took tens of seconds and was focused in the rear of the motorcoach, so the CO volume fractions peaked at about 3.3% about 30 seconds after extinguishment were started for both the front and middle positions.

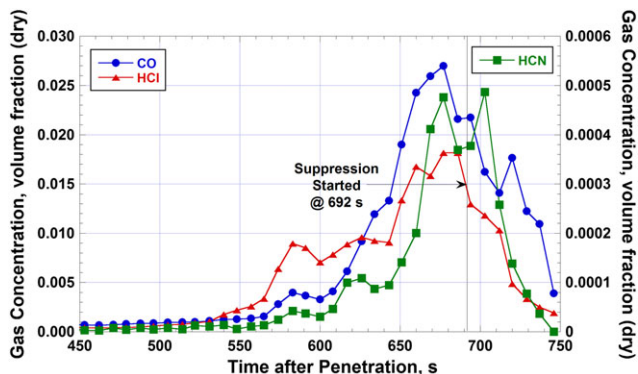
FIGURE 17 CO, HCl, and HCN volume fractions measured with FTIR at the rear sampling location plotted versus time after penetration [Colour figure can be viewed at wileyonlinelibrary.com]

Figure 17 is a plot of some of the gases measured using FTIR at the rear sampling position in the motorcoach. The CO volume fraction is slightly lower but comparable with the analyzer measurement at the same location. HCl peaked at about 1.5% while HCN only reached about 500 µL/L.

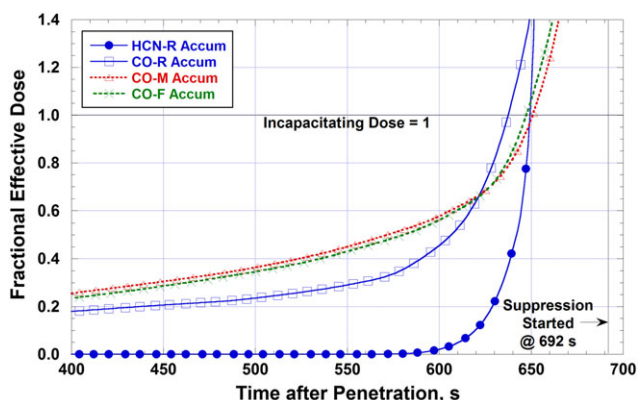
FIGURE 18 Fractional effective doses for HCN and CO measured at the rear (R), middle (M), and front (F) sampling locations plotted versus time after penetration [Colour figure can be viewed at wileyonlinelibrary.com]

The two terms are plotted separately in Figure 18 for the rear (CO and HCN), middle (CO), and front (CO) sampling positions. When acting alone, the time after penetration to incapacitation was 649 seconds

for rear HCN,[†] 637 seconds for rear CO, 651 seconds for middle CO, and 647 seconds for front CO. Combining the rear HCN with the CO for each position results in the plot in Figure 19. All the curves converge because of the strong influence of HCN on the totals. The incapacitating dose is reached within 2 seconds of 631 seconds for all three positions. The time to untenable conditions throughout the motorcoach due to these gases was 10 minutes 33 seconds after penetration.

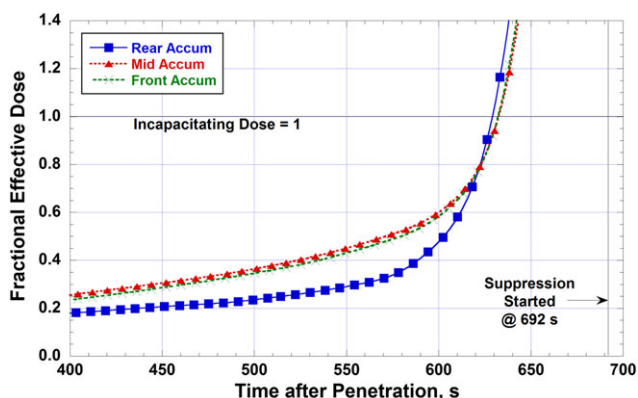
FIGURE 19 Total (both CO and HCN) fractional effective doses for the rear (R), middle (M), and front (F) sampling locations plotted versus time after penetration [Colour figure can be viewed at wileyonlinelibrary.com]

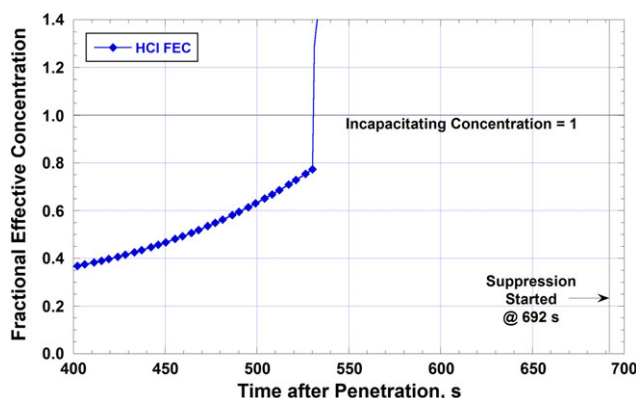
FIGURE 20 Fractional effective concentration for HCl measured with Fourier transform infrared spectrometer at the rear sampling location plotted versus time after penetration [Colour figure can be viewed at wileyonlinelibrary.com]

The plot in Figure 20 shows that the FEC for HCl increases rapidly at 530 seconds after penetration and crosses the incapacitating dose line at 531 seconds, which is 8 minutes 51 seconds after penetration.
