BMFE-08 Biarritz, France, 4-5 March 2020

PRESENTATION OF AN EXPERIMENTAL STUDY OF A MOTORCOACH TIRE FIRE

STUDIES OF REFERENCE

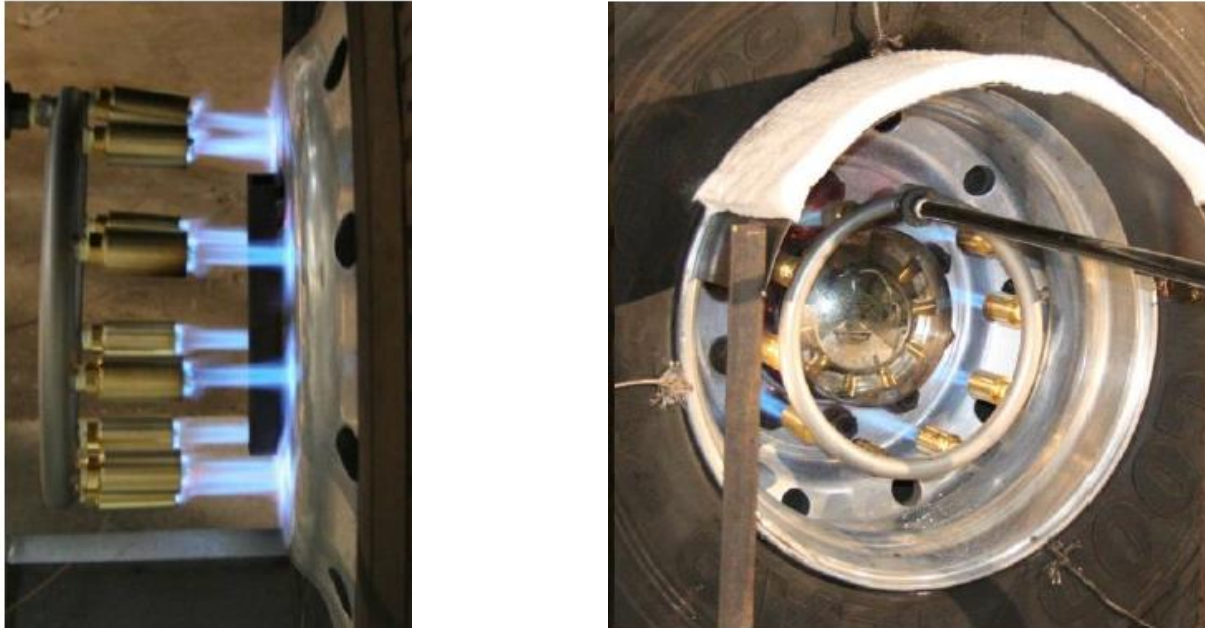
Figure 2 (Left) A photograph showing the burner pre-mixed natural gas and air torches impinging on a tag axle wheel. (Right) A photograph showing the tire shield inside a drive axle wheel rim with an insulating cover to minimize heating from the shield to the tire.

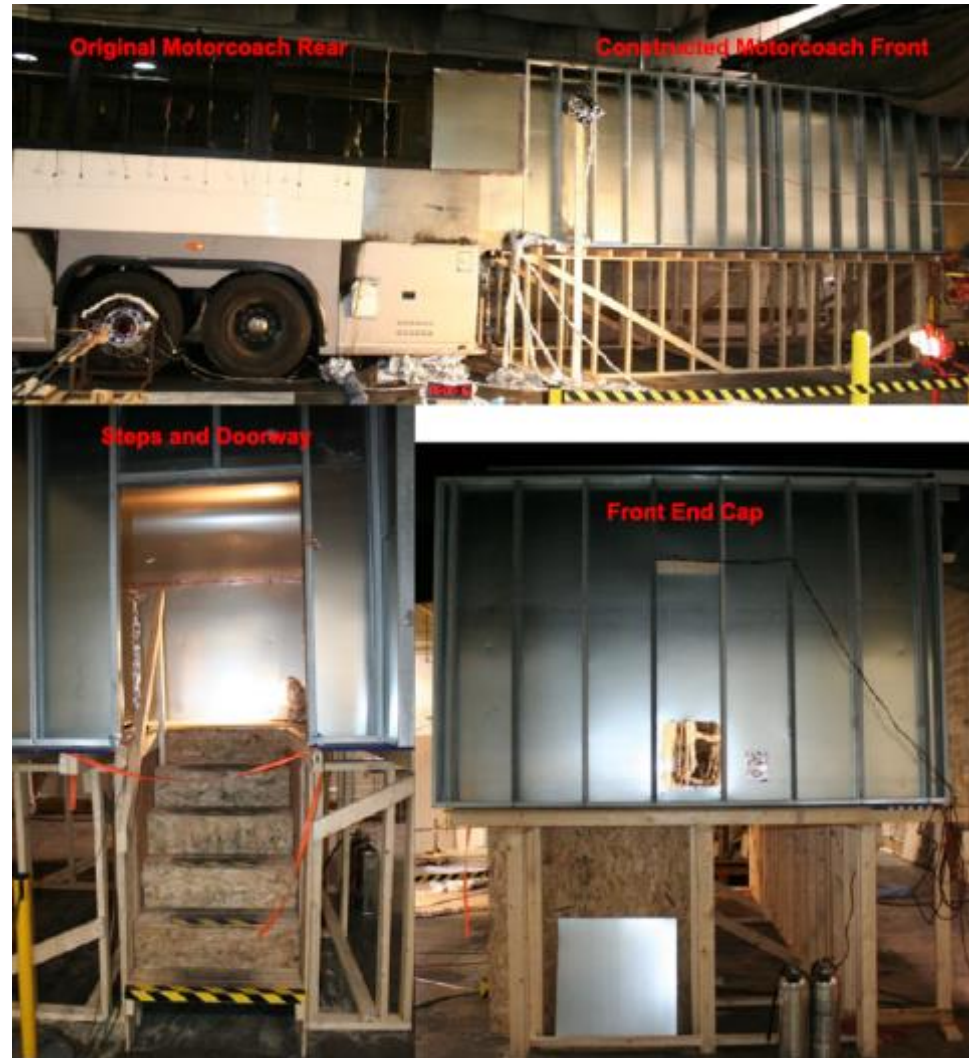
- ❑ The constructed front of the motorcoach consisted of a wood frame structure upon which a steel stud frame was built and to which a galvanized sheet steel interior skin was attached
- ❑ The doorway matched that of an MCI E-series coach
- ❑ Original furnishings and trim components were reinstalled
- ❑ The components were required to pass the burner test prescribed in FMVSS 302
- ❑ The seats were composed of fabric over polyurethane foam

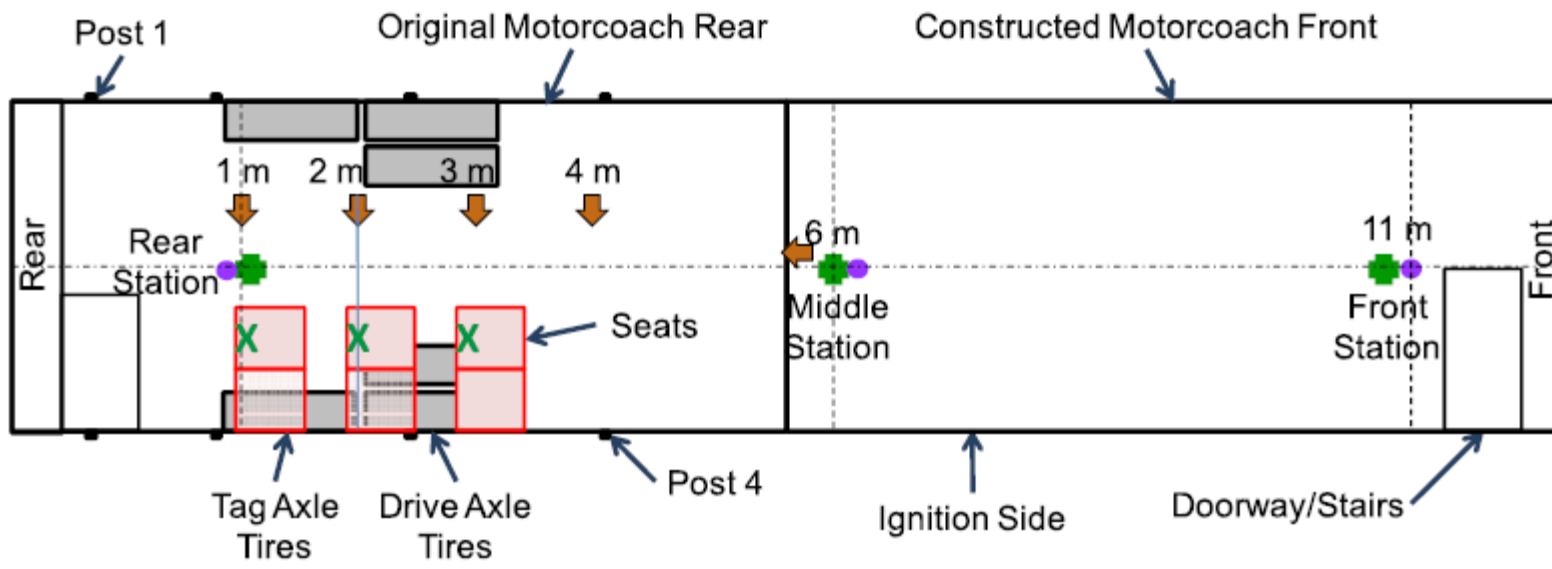
Plan View

- ↓ Heat Flux Gauges (5)
- Gas Sampling Probes (3)
- Thermocouple Arrays (3)
- X Single Thermocouples
(3 on headrests, 3 on parcel rack doors)

- 3 vertical thermocouple arrays (5 TC each) installed in rear, middle and front locations

- 4 HF gauges

- CO, CO₂, O₂, THC, HCL, HCN

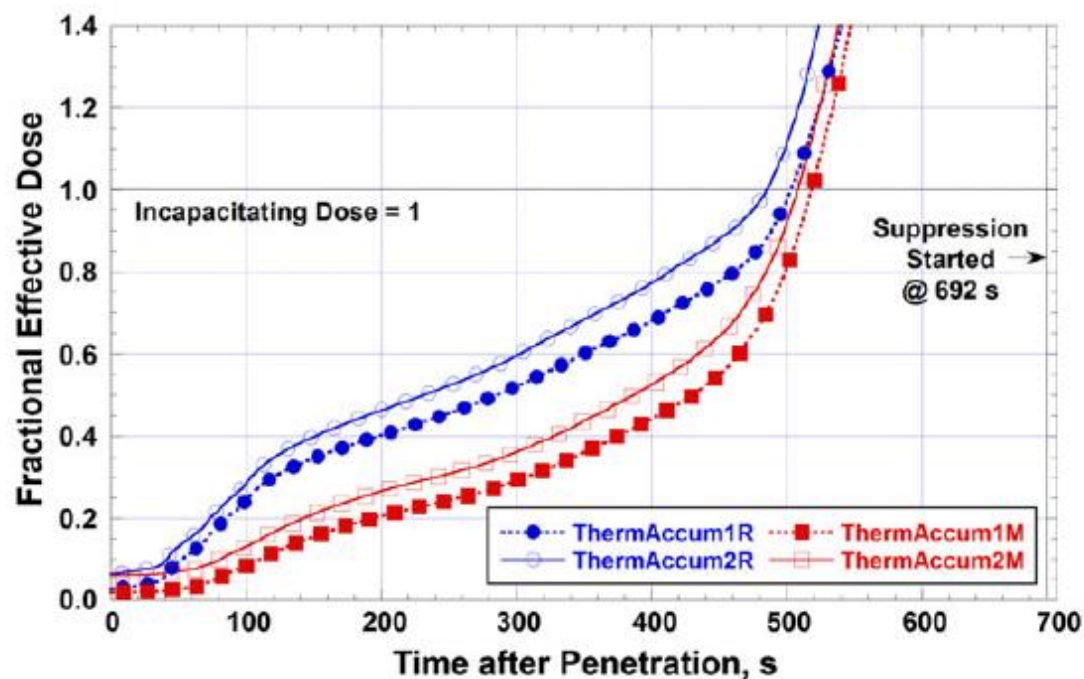
- ❑ Thermal = radiative + convective
- ❑ 2 models: fully clothed or lightly clothed occupants

FIGURE 15 Fractional effective doses from combined radiation and convection plotted versus time after penetration for the rear (1-m) and middle (6-m) heat flux gauges and thermocouples 1.5 m above the floor. The type 1 analysis treats occupants as fully clothed while type 2 is for more lightly clothed occupants with more skin exposure

- ❑ Thermally untenable conditions were reached by about 8 minutes (rear and middle) after fire penetration
- ❑ CO and HCN combined to make conditions untenable just under 11 minutes after fire penetration, and HCl caused untenable conditions just under 9 minutes (rear) after fire penetration

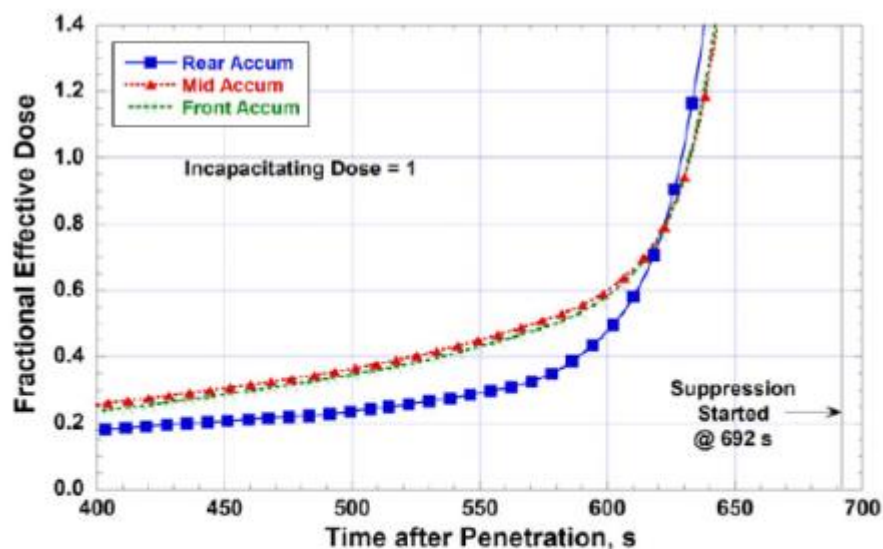
- ☐ Toxicity models: asphyxiants (FED) & irritants (FEC)

FIGURE 19 Total (both CO and HCN) fractional effective doses for the rear (R), middle (M), and front (F) sampling locations plotted versus time after penetration [Colour figure can be viewed at wileyonlinelibrary.com]

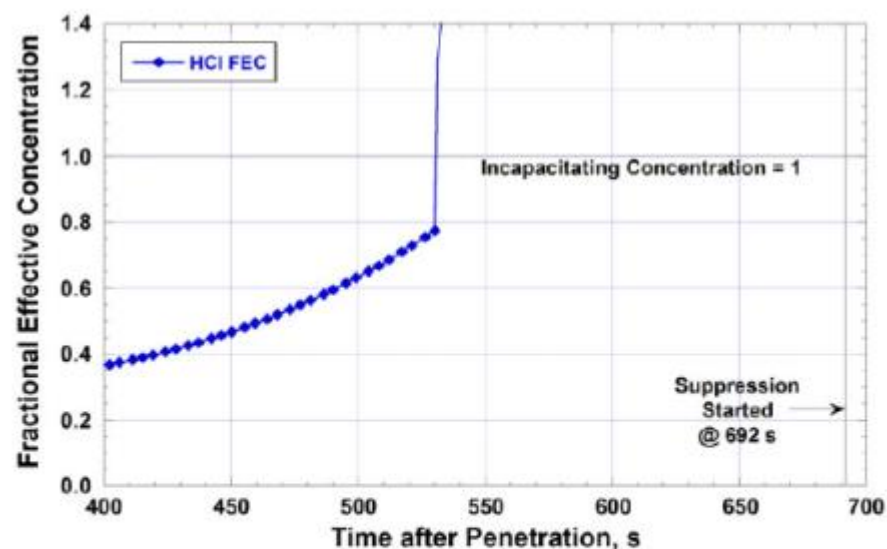
FIGURE 20 Fractional effective concentration for HCl measured with Fourier transform infrared spectrometer at the rear sampling location plotted versus time after penetration [Colour figure can be viewed at wileyonlinelibrary.com]

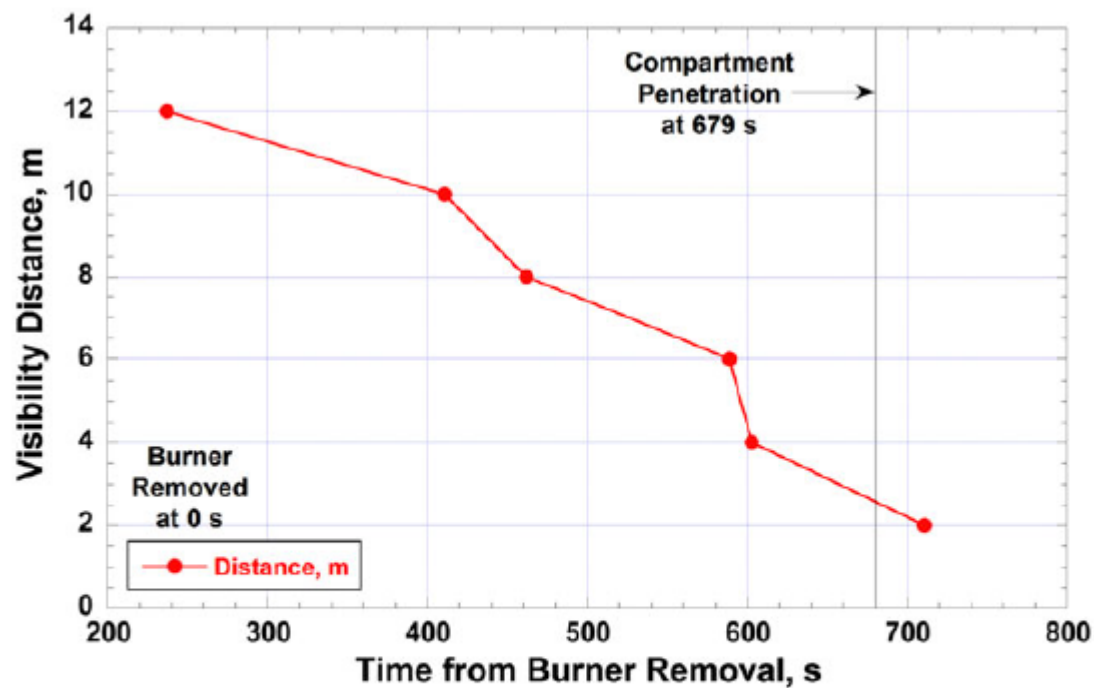
FIGURE 21 Visibility distance plotted versus the time from burner removal for the exit signs [Colour figure can be viewed at wileyonlinelibrary.com]

- ❑ Visibility conditions deteriorated significantly prior to fire penetration: Within 30s after penetration, visibility decreased to less than 2 m
- ❑ The combination of three pairs of seats and partial trim installation was sufficient to cause flashover in the rear in less than 11 minutes after fire penetration
