# 挤压试验 crush test

# 挤压试验 Crush test

## 整车碰撞时电池的变形表现

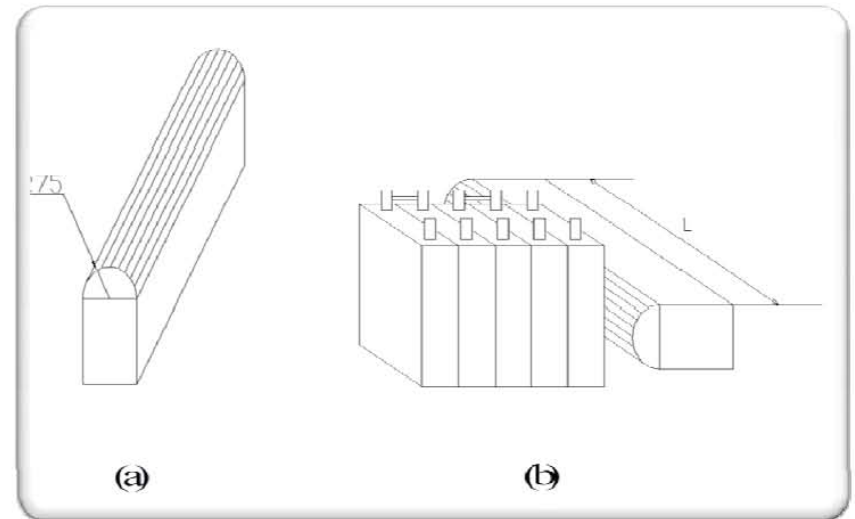
- battery is fully charged;
- Radius of 75 mm half cylinder, the length of the cylinder is greater than the battery, but not more than 1 m;

Crush from the most vulnerable direction or perpendicular to the orientation of monomer battery.

The deformation is 30%, or pressure meet the requirements of table;

Keep for 10 min.
