FATAL CAR TO MOOSE COLLISIONS: REAL-WORLD IN-DEPTH DATA, CRASH TESTS AND POTENTIAL OF DIFFERENT COUNTERMEASURES

Paper Number 17-0294

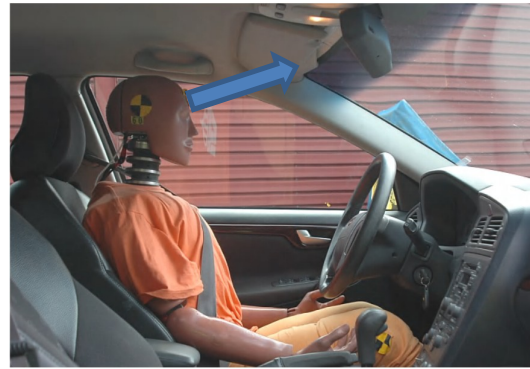
Figure 1. Distance between head and header structure

The measured pre distance between head and header structure is shown in Table 1. A HIII 50th male dummy was used on the driver's seat and the head acceleration was measured.

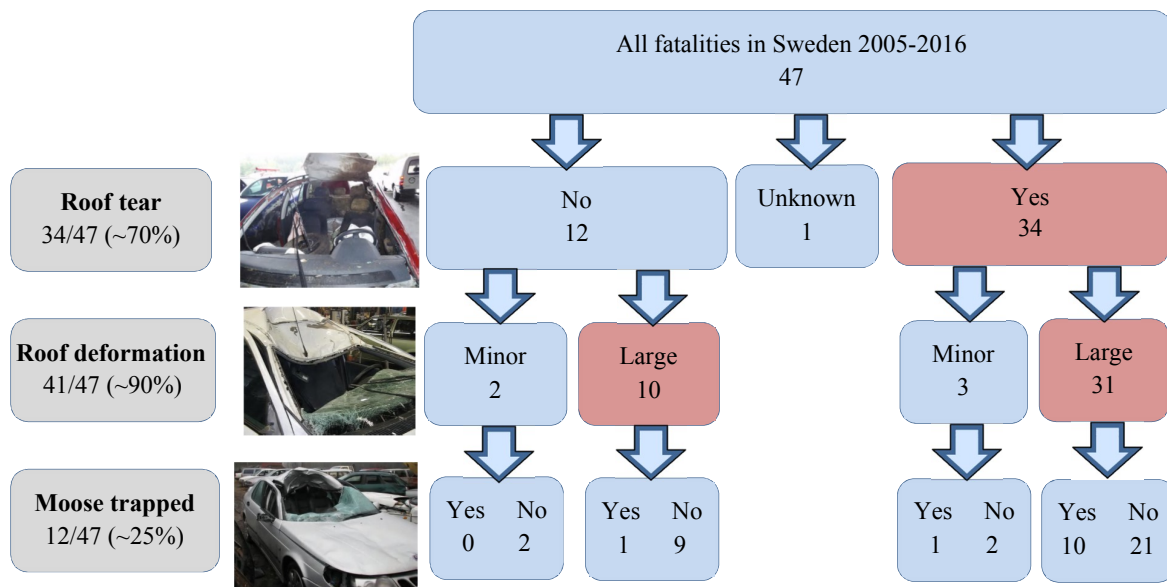
Figure 8. Number of fatalities divided into groups of roof tear along door frame, downward deformation of header structure and moose trapped.

Figure 8 shows the number of fatalities in relation to the car deformation characteristics. The three most important factors for a fatal outcome were the amount of roof tear and vertical deformation of the roof and whether the moose was trapped in the occupant compartment or not. A large portion of the fatalities (31/47) occurred in case of large roof tear and in combination with large vertical roof

deformation. Large roof deformation alone accounted for 10 fatalities. Downward roof deformation without roof tear was strongly correlated with deformed A-pillars. A trapped moose was most often (10/47) combined with roof tear and large vertical roof deformation.

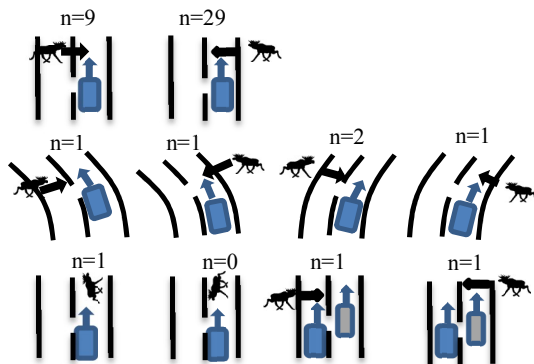
Figure 9. Collision type and number of fatalities per collision type

The most common MVC type was on a straight road with the moose coming from the right side (Figure 9). The large portion of fatal moose collisions from the right side (66%) may be explained by the difficulties to detect a moose from the right side compared to the left side. The most demanding situation is a collision in combination with overtaking at high speed and also with an obstructed view. Two collisions occurred during overtaking.
