UNECE EVS-IWG

OICA comments on Water Immersion EVS #25 meeting 2022

Feedback on Water Immersion Test

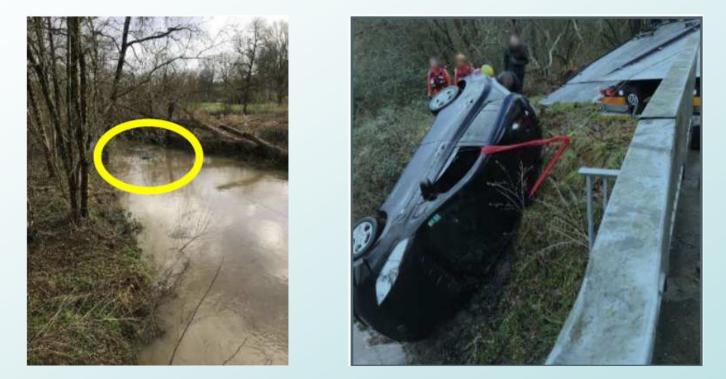
NISSAN LEAF - loss of control

Circonstances: Human Failure Function: Guidance issue -sudden perturbation

Explicative element: Environment-Road surface -hail shower

Consequences: The 2 occupants left the vehicle through their window, went back home being very lightly injured. The vehicle has been towed off the water on the following day.

No case of electrification No electrical issue reported No fire No explosion

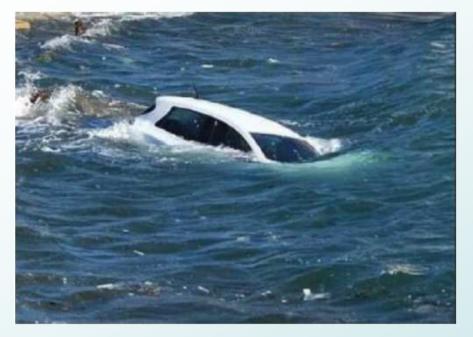
RENAULT ZOE in the sea

No case of electrification nor electrical issue reported No fire No explosion
