Share of Korea's Progress in ACPE GTR Activities

Korea Automobile Testing & Research Institute (KATRI)

Status of Two Planned Studies on ACPE GTR Activity

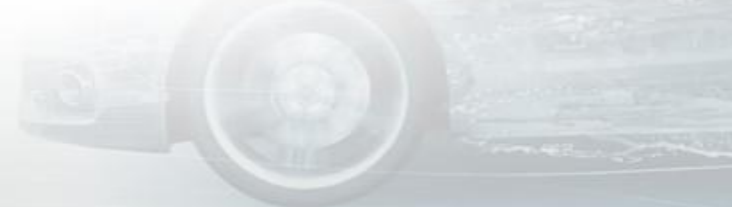
Study #2 — 9 EDR Cases Overview

Vehicle, powertrain and trigger scenario for each of the 9 secured 10 Hz EDR records

No	vehicle	Power-train	Obstacle	Steering	Auto hold status	Speed (kph)	APS TRAVEL	APS Rate (average)	UNR175 Prevent	why?	Front Dashcam
1	SUV	Hydrogen	vehicle	✓ (Left)	✓	4	99%(←25%)	185%/s	✗	under 400%/s	✓
2	SUV	hybrid	vehicle	✗	✓	3	100%(←26%)	185%/s	✗	under 400%/s	✗
3	Sendan	Electric	Unknown	✗	✗	8	76%(←20%)	112%/s	✗	at APS 76%, Crash occurred	✗
4	Sendan	Gasoline	No obstacle	✗	✓	13	90%(←21%)	76.67%/s	✗	under 400%/s	✓
5	Sendan	Disel	Vehicle positioned at an angle	✗	✓	12	100%(←0%)	1,000%/s	△	Vehicle positioned at an angle	✓
6	SUV	Electric	vehicle	✗	✓	4	99%(←31%)	97%/s	✗	under 400%/s	✓
7	SUV	Electric	No obstacle	✓ (Right)	✗	17	86%(←16%)	35%/s	✗	under 400%/s	✓
8	Sendan	Gasoline	vehicle	✗	✓	3	100%(←0%)	1,000%/s	✓		✓
9	Sendan	Gasoline	wall	✓ (Left)	✓	0	98%(←33%)	325%/s	✗	under 400%/s	✓

- Analysis is currently in progress for all 9 cases.
- An overview of the 9 cases — vehicle, powertrain, scenario and pedal rate — is presented on the following slide.
