TEST REPORT

Hydrogen Container Performance Testing

UN GTR No. 13

Test Report Number: TR-00663-01-R2

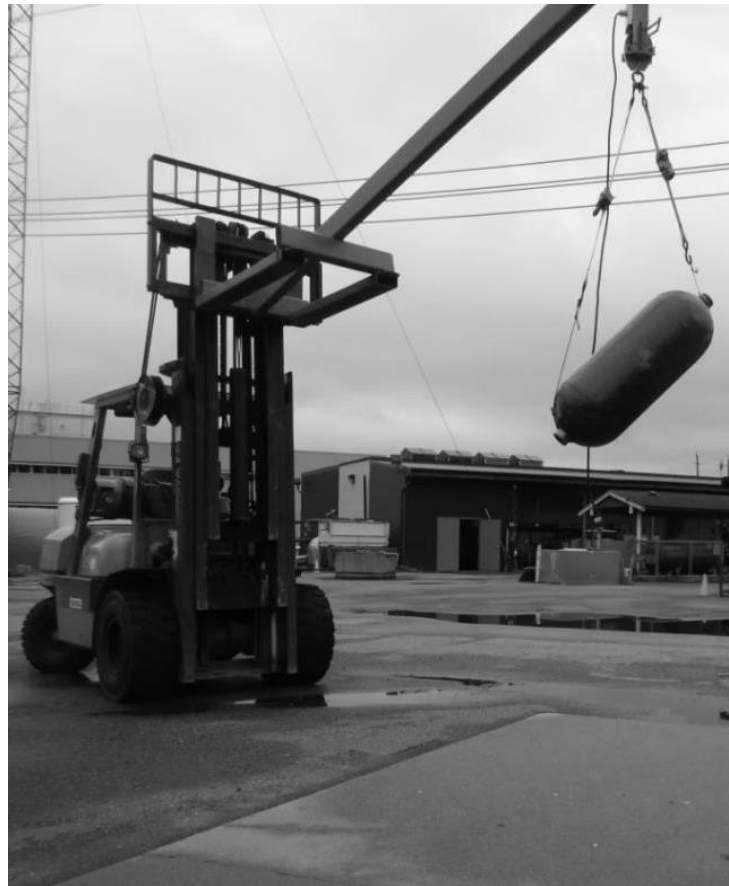
Figure 4: Drop Test Setup

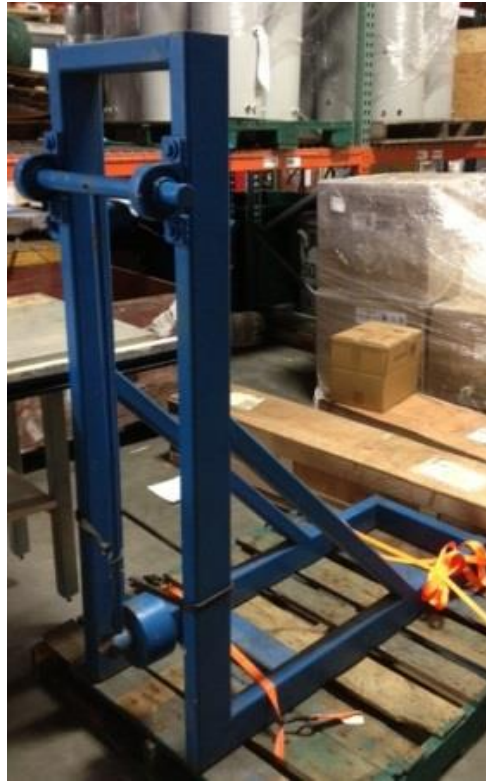
Figure 6. Image of pendulum machine

The sensors and equipment used for the surface damage test are shown in Table 12. During the test, the device was positioned such that the pendulum impacted the container at a 90° angle. A photo of the pendulum machine and a close-up image of the pendulum head are shown in Figure 6 and Figure 7 respectively.

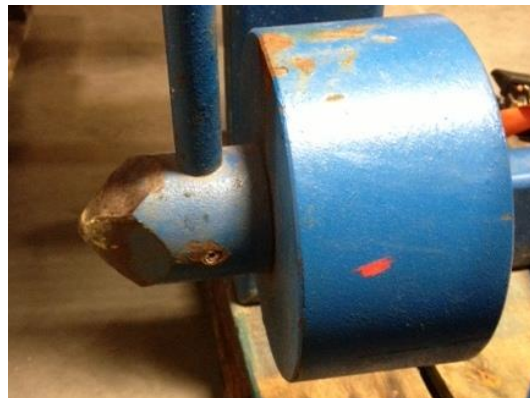
Figure 7. Pendulum head

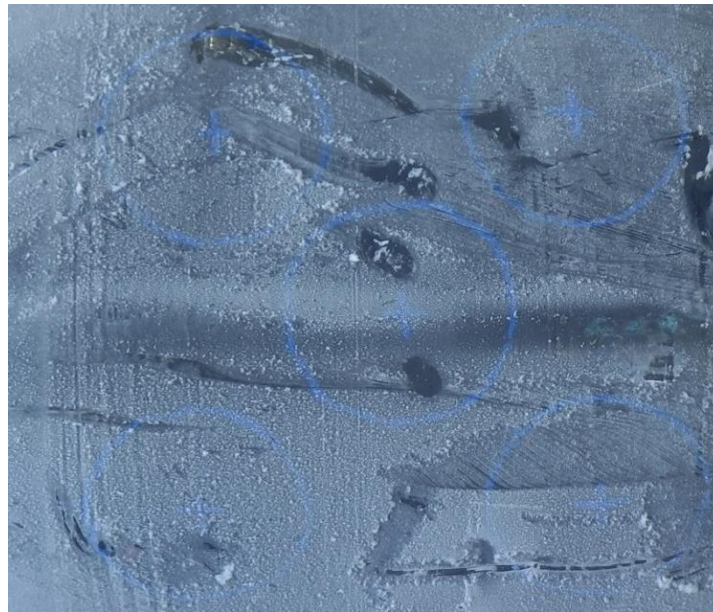
Figure 9. Container 2-E prior to pendulum impact

All three containers were subjected to the surface damage test. The conditioning times at -40°C prior to the impact test are shown in Table 13. An image of the two flaws cut into the container surface is shown in Figure 8. Images of container 2-E prior to and after the pendulum impact are shown in Figure 9 and Figure 10.

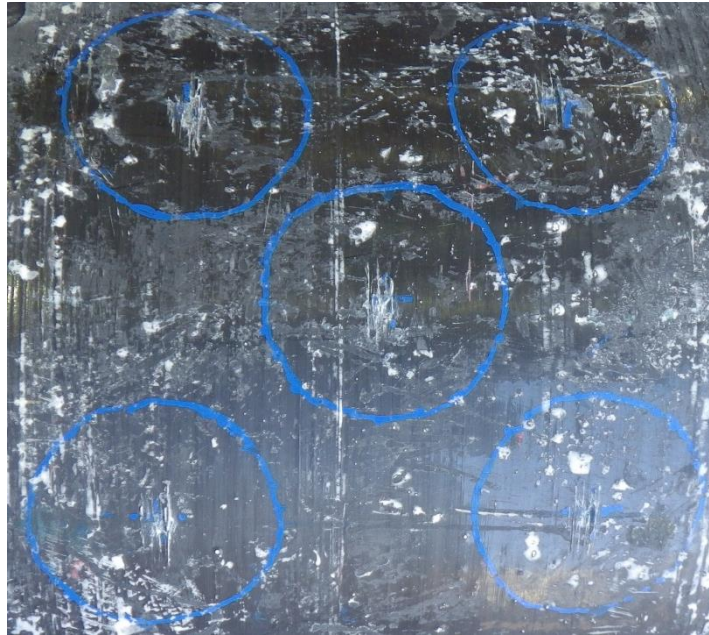
Figure 10. Container 2-E after pendulum impact

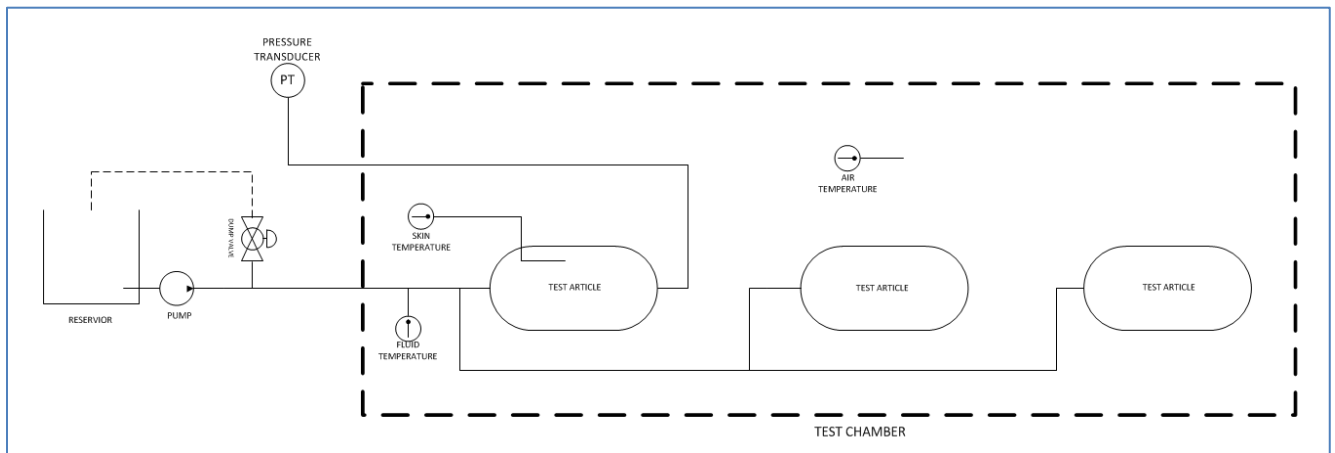
Figure 11. Chemical Exposure and Ambient Temperature Pressure Cycling Test Setup

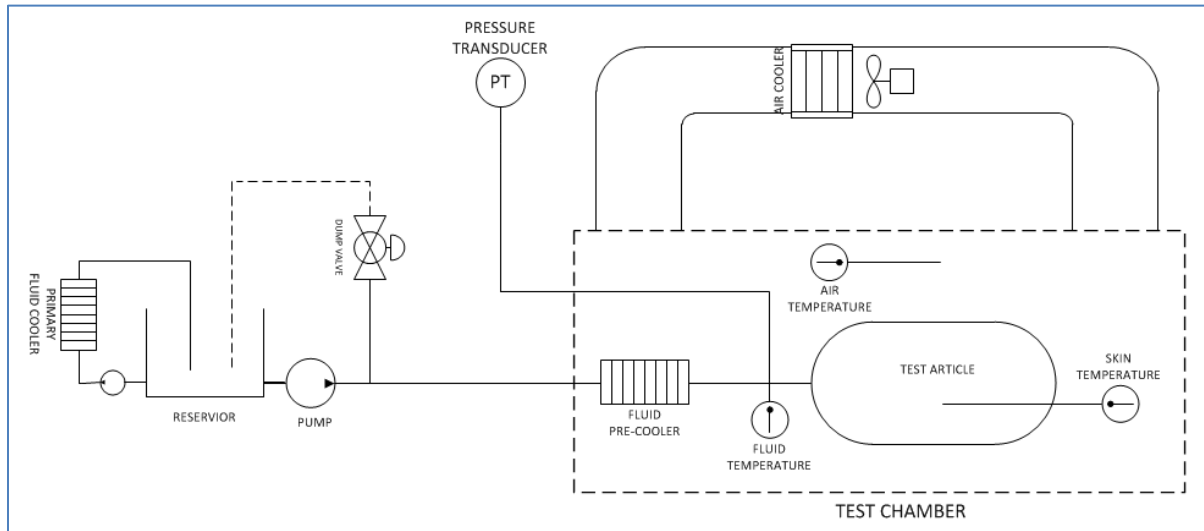
Figure 15. Cold Pressure Cycling Test Setup

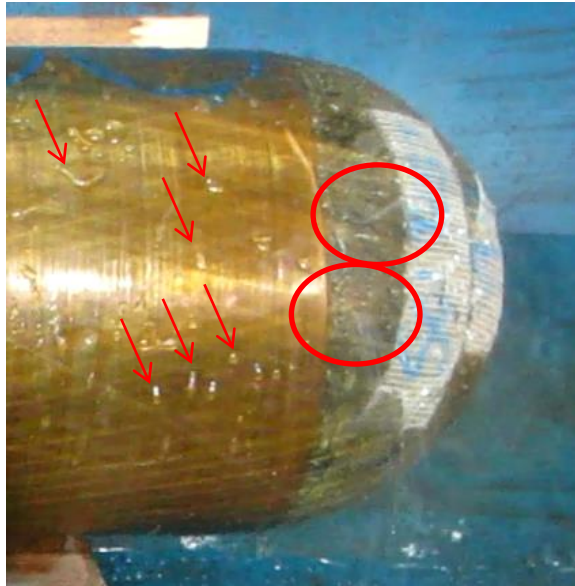
Figure 17. Leakage from dome and sidewall of container 3-E during hot pressure cycling

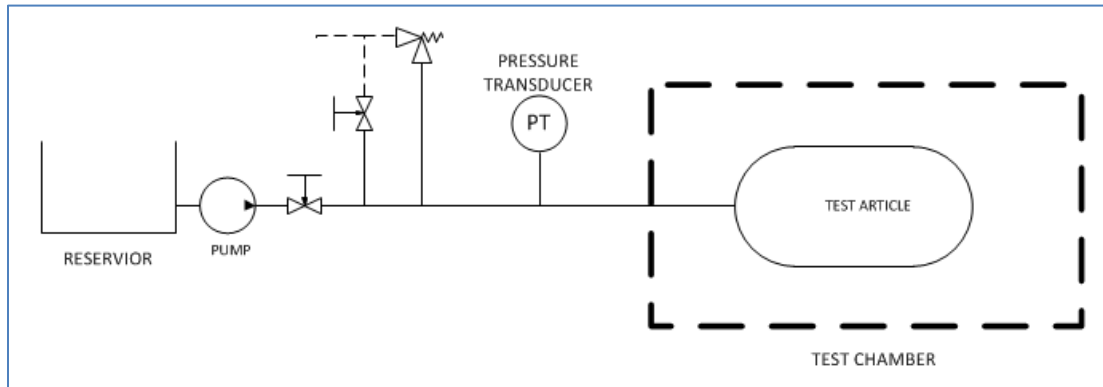
Figure 20. Proof Pressure Test Setup

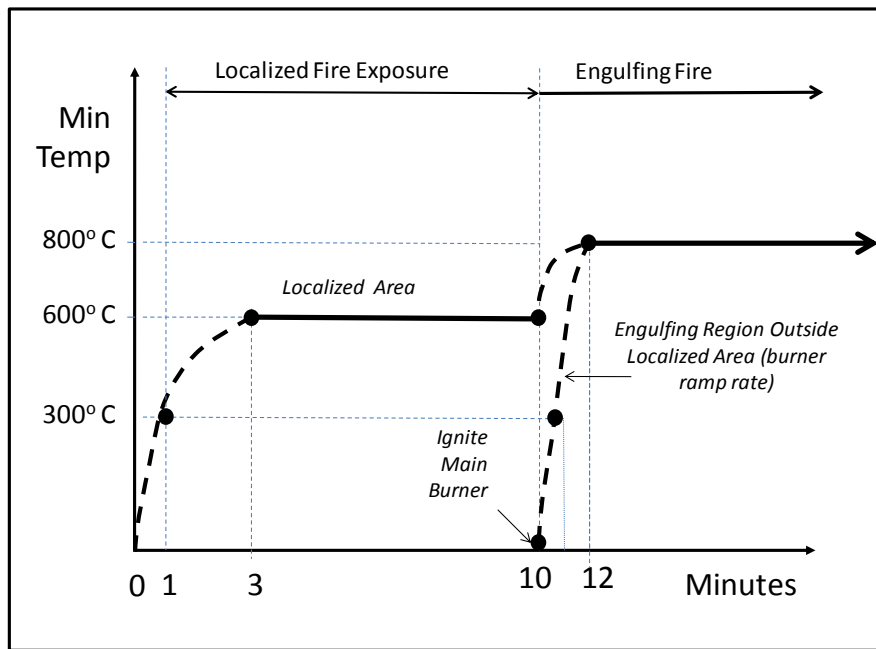
Figure 24. Localized Fire Test Temperature Profile

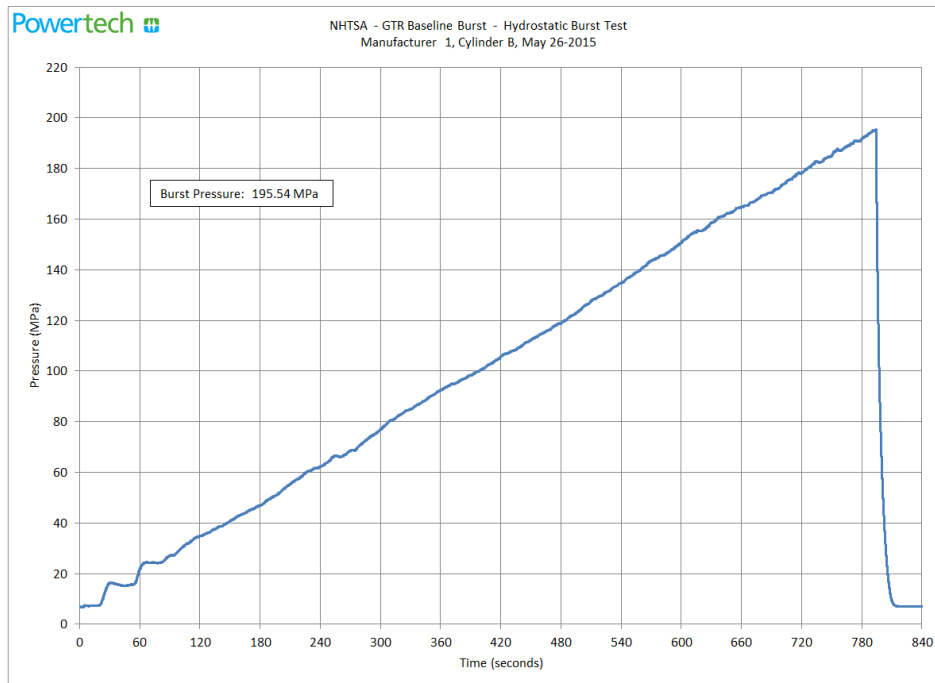
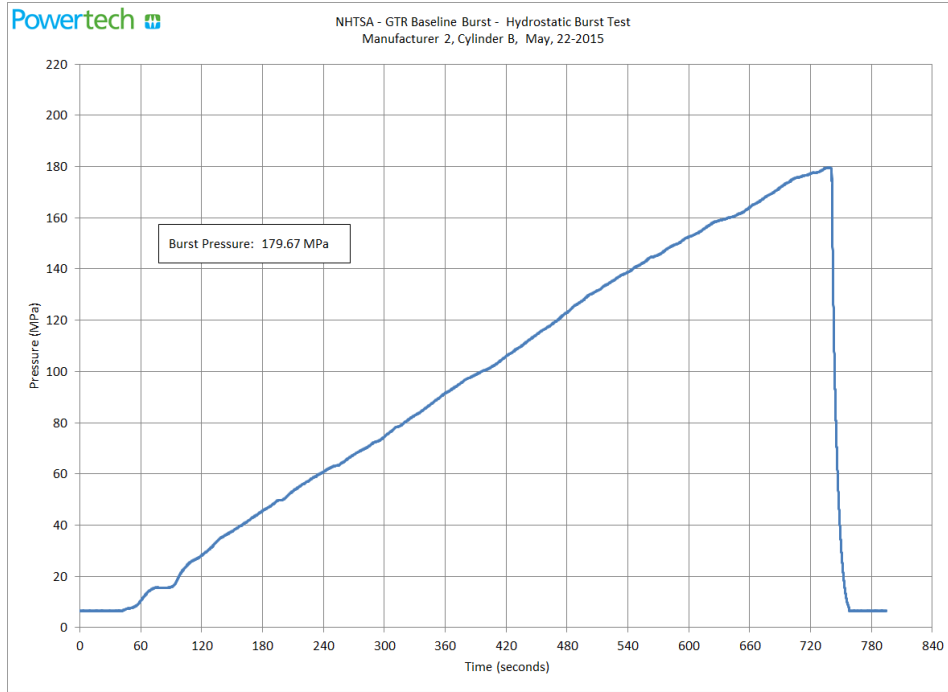
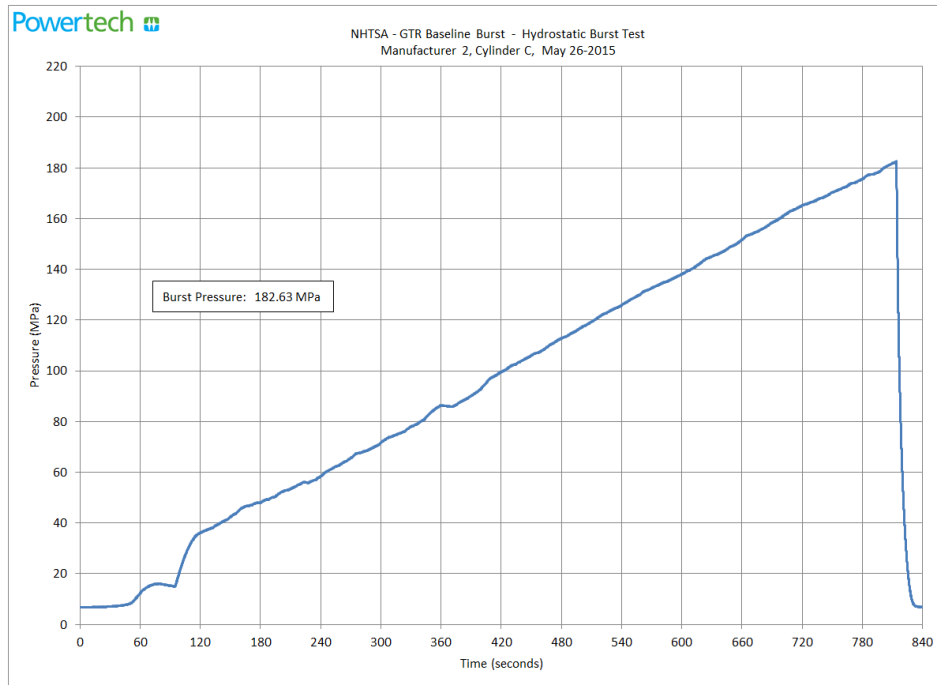
Figure 26. Baseline Burst Pressure Plot of Container 1-A

Figure 27. Baseline Burst Pressure Plot of Container 1-B

Figure 28. Baseline Burst Pressure Plot of Container 1-C

Figure 29. Baseline Burst Pressure Plot of Container 2-A

Figure 30. Baseline Burst Pressure Plot of Container 2-B

Figure 31. Baseline Burst Pressure Plot of Container 2-C

Figure 32. Baseline Burst Pressure Plot of Container 3-A

Figure 33. Baseline Burst Pressure Plot of Container 3-B

Figure 34. Baseline Burst Pressure Plot of Container 3-C

All container burst pressures were found to be within ± 10 per cent of the BPO and above the minimum burst pressure requirement (BPmin) of 157.5 MPa. The baseline burst test results are shown in Table 4. Burst pressure charts are shown in Figure 26 to Figure 34 in Appendix A.

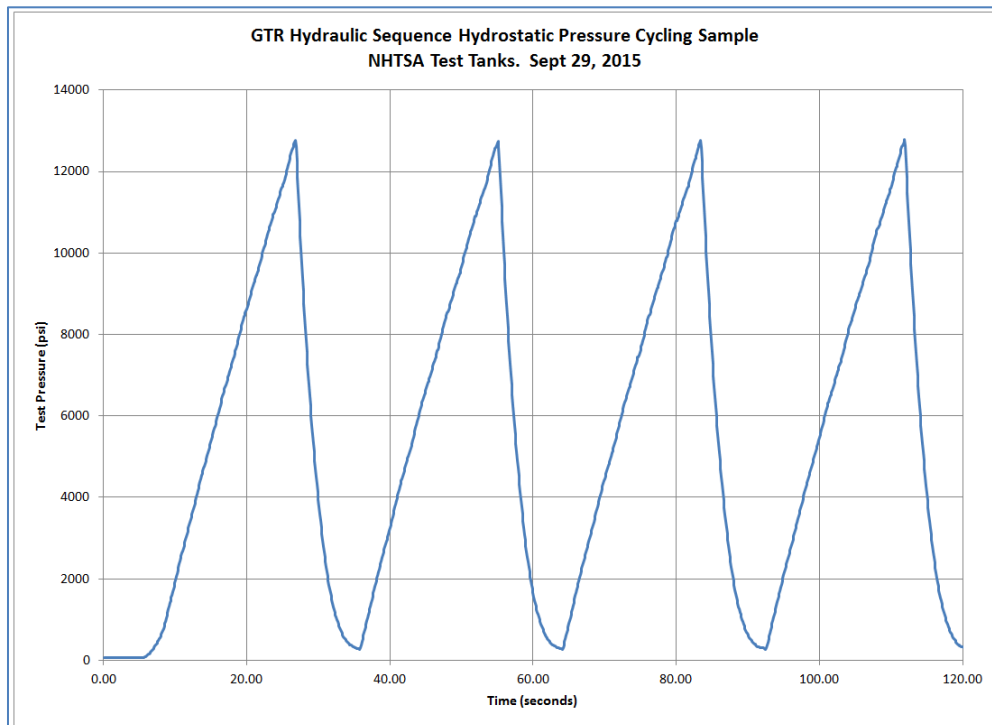
Figure 35. Hydraulic Sequence Ambient Pressure Cycling Profile

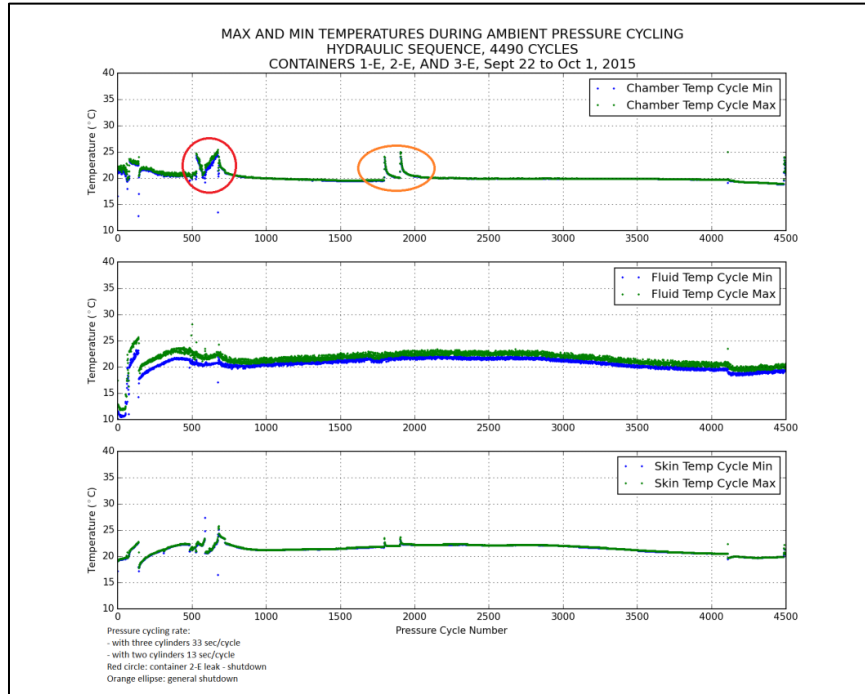
Figure 36. Max and Min Temperatures during ChemEx Ambient Cycles to 1.25xNWP

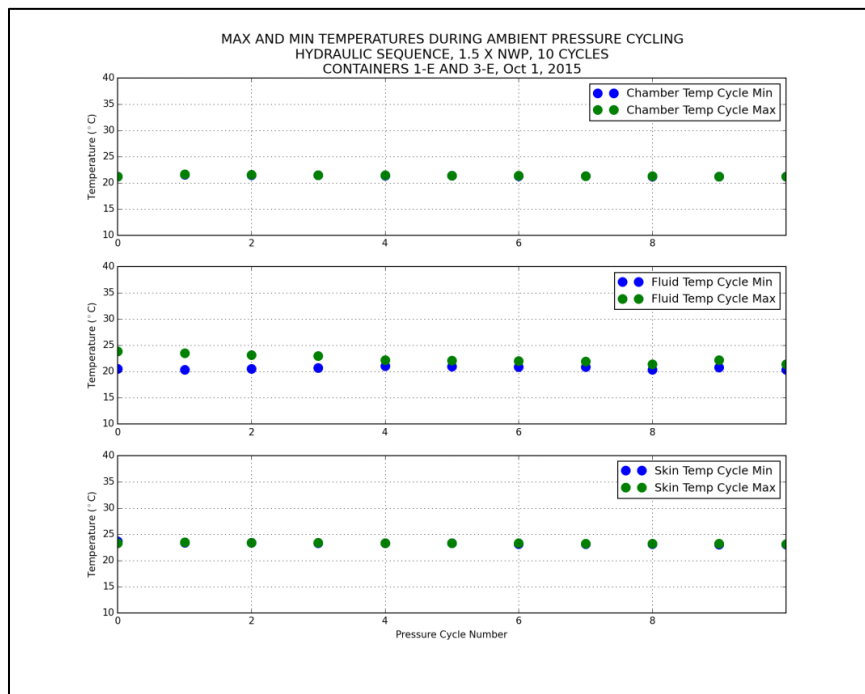
Figure 37. Max and Min Temperatures during last 10 ChemEx Ambient Cycles to 1.5 x NWP

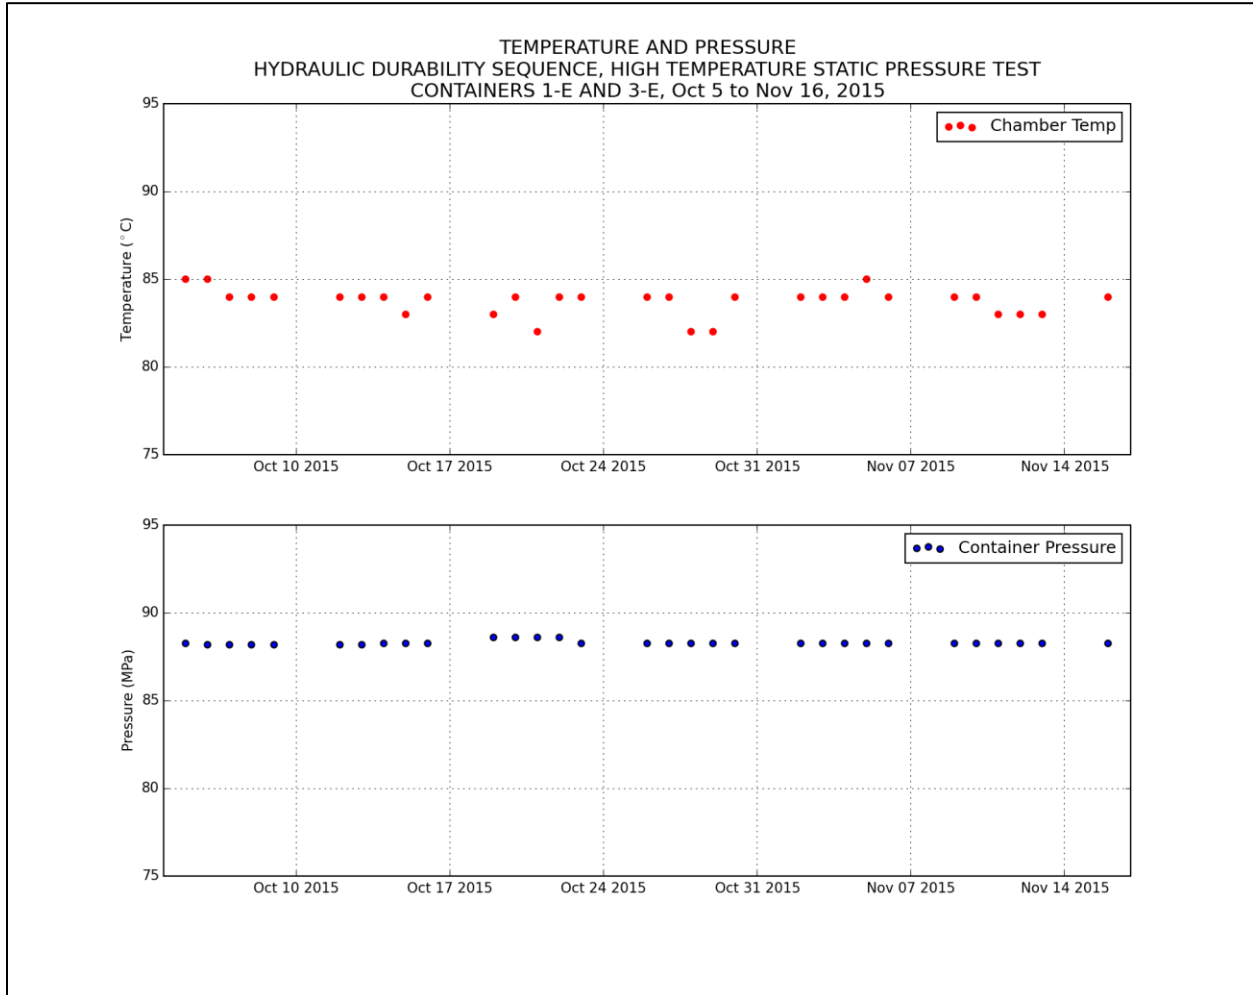
Figure 38. Temperatures and pressures during high temperature static pressure sequence

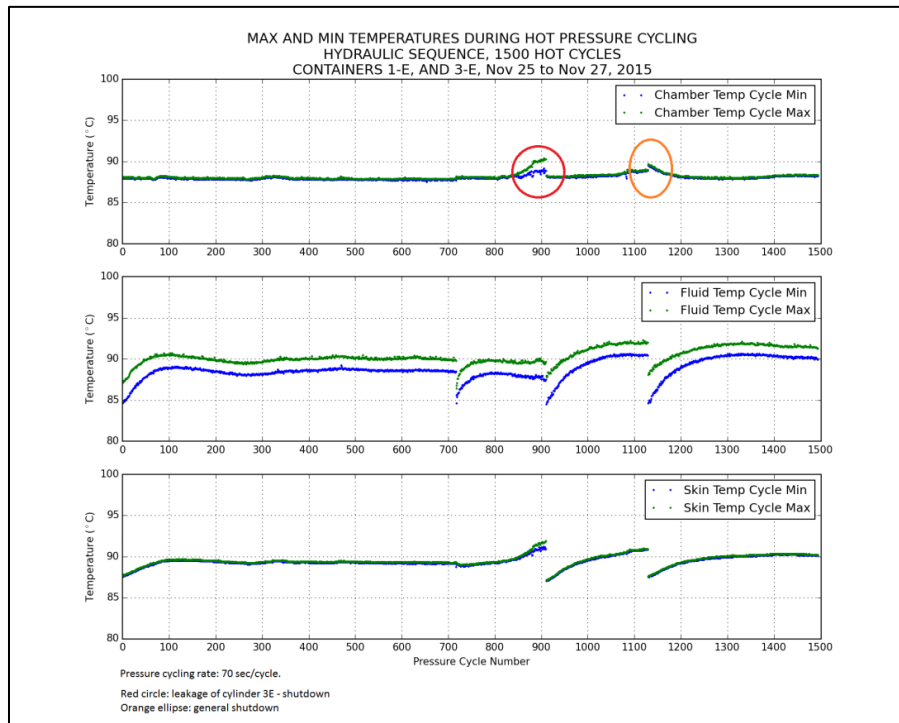
Figure 40. Temperatures recorded during hot pressure cycling

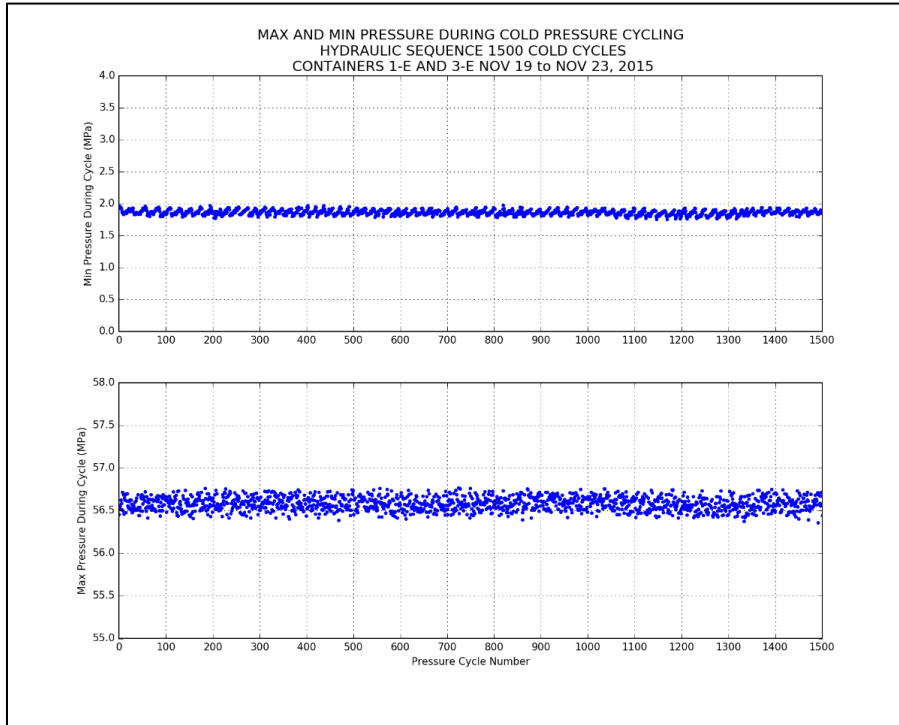
Figure 41. Max and min pressures recorded during cold pressure cycling

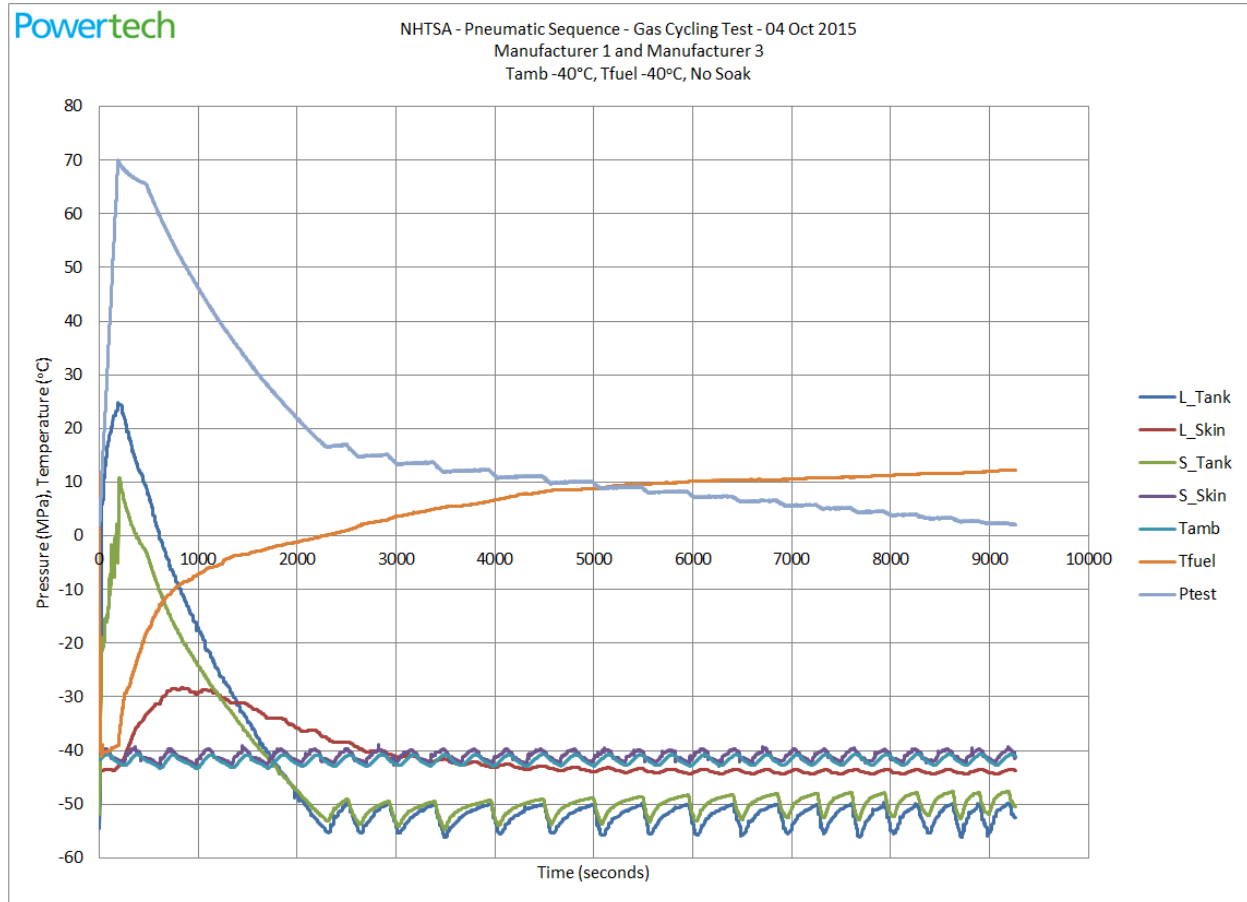
Figure 48. Gas Cycling Test Stage 3 – cold cycles, full cycle

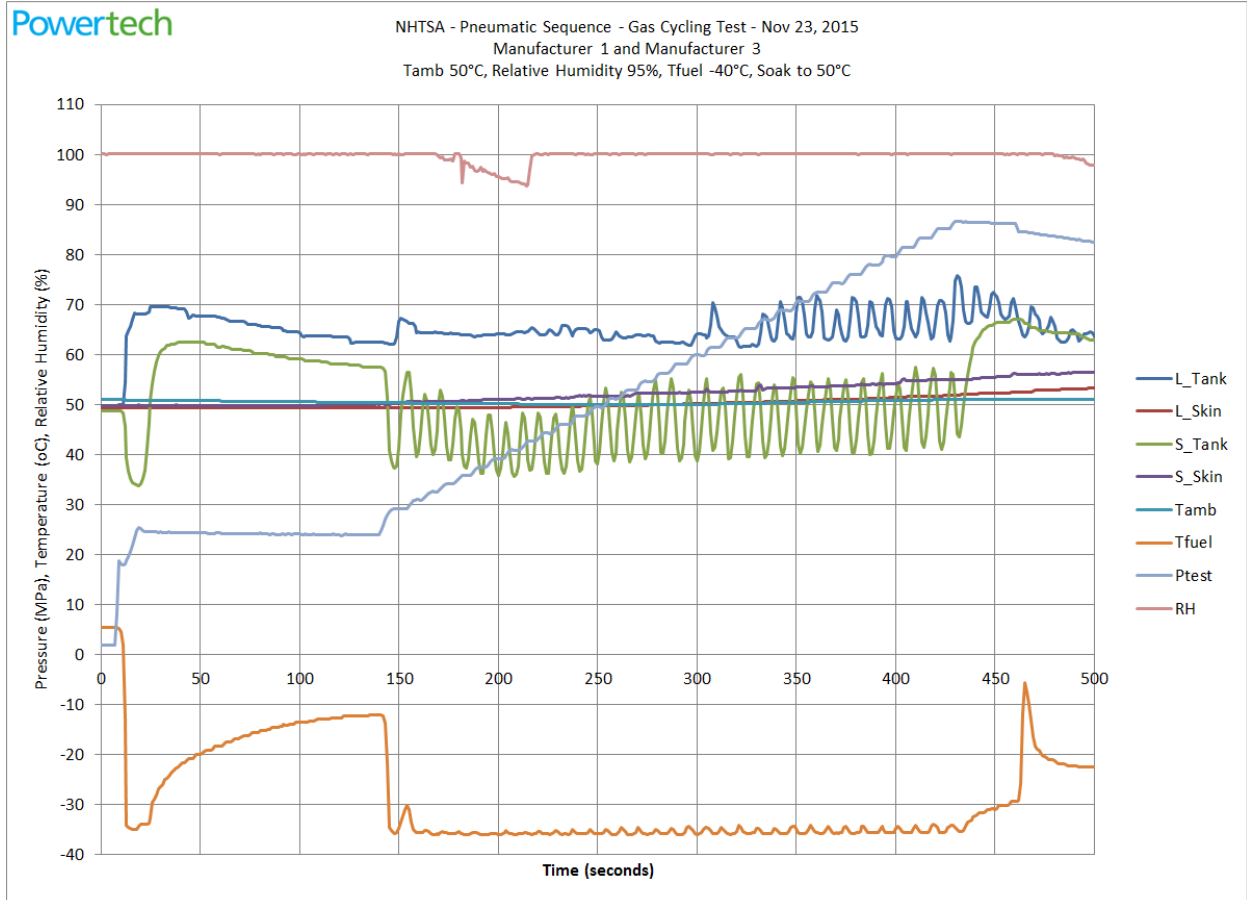
Figure 51. Gas Cycling Test Stage 4 – hot soak cycles, fill profile

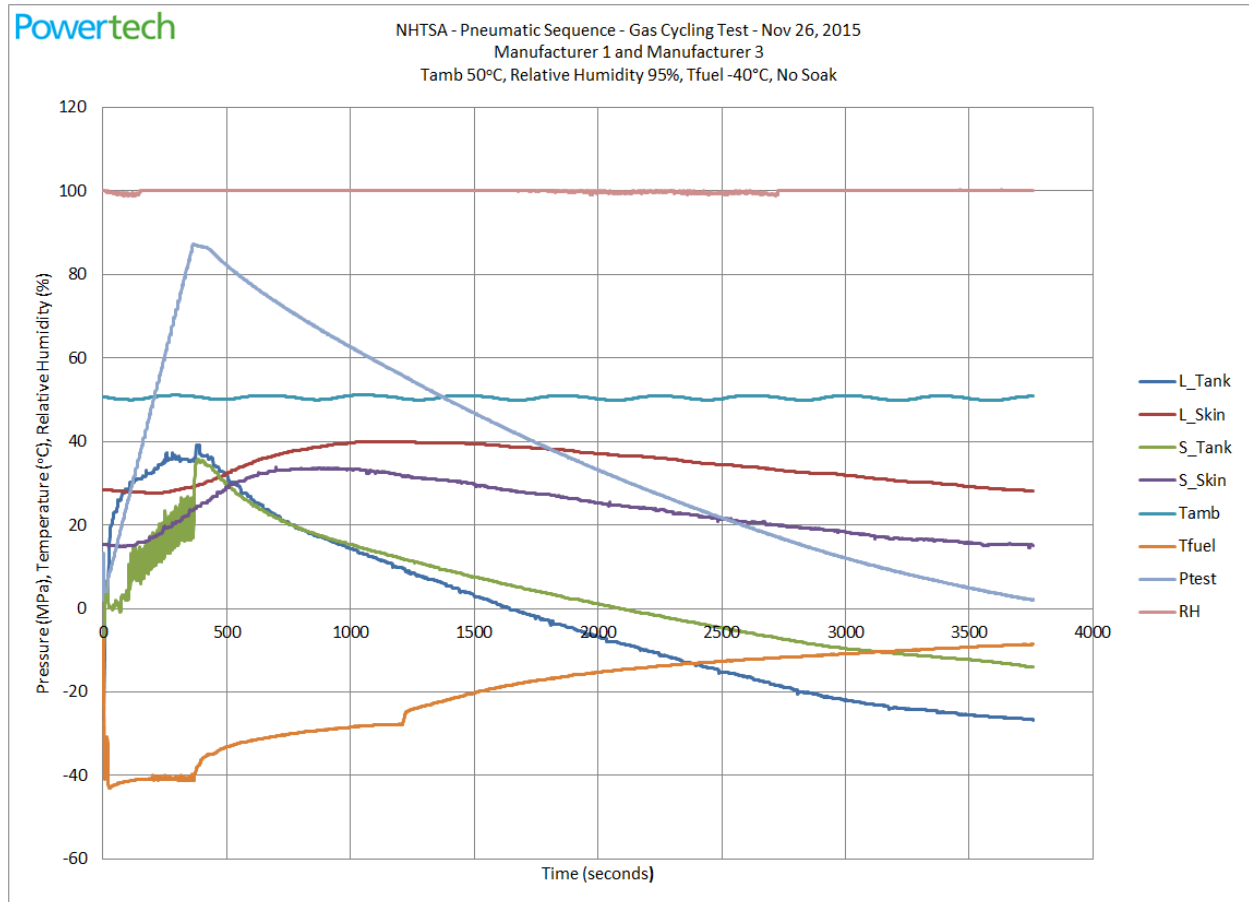
Figure 52. Gas Cycling Test Stage 5 – hot cycles, full cycle

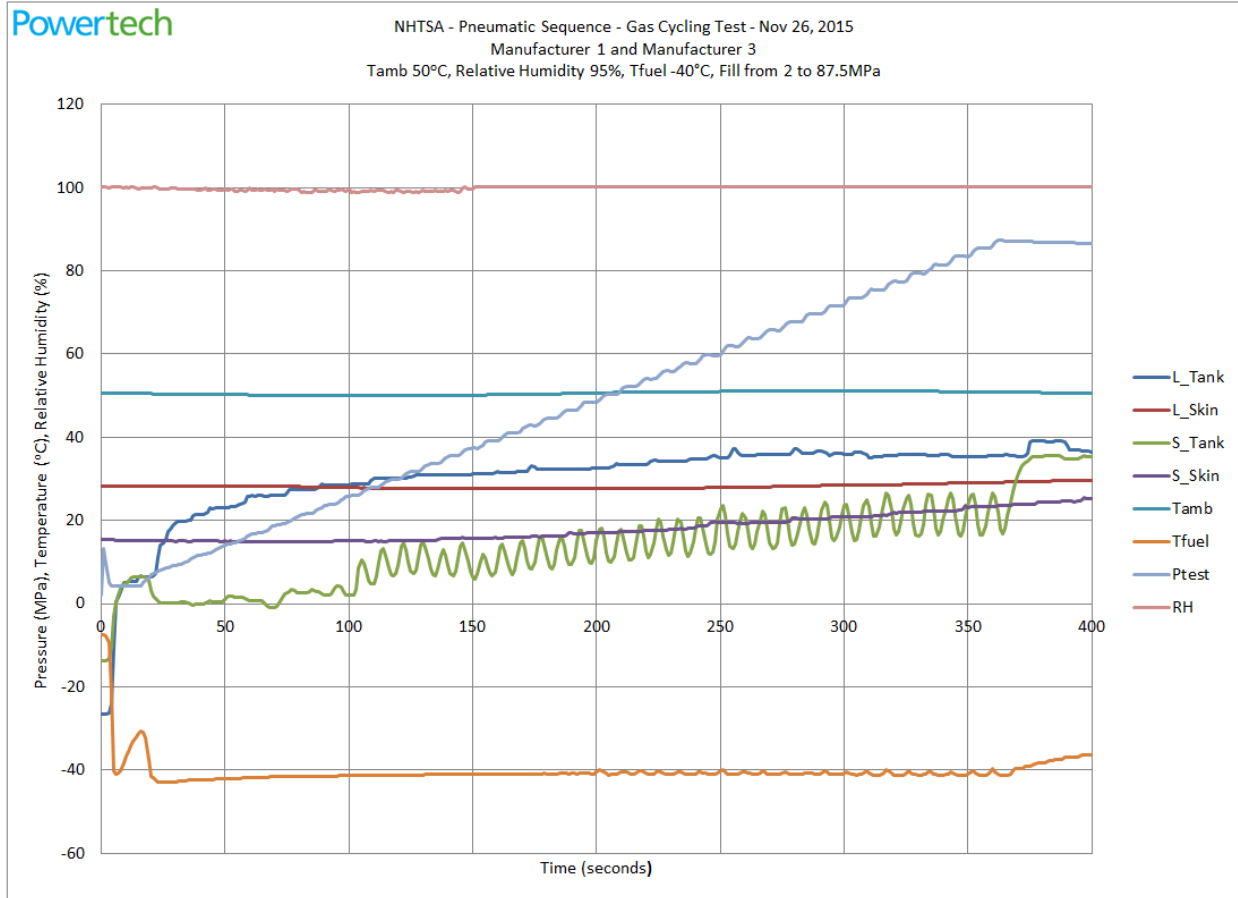
Figure 53. Gas Cycling Test Stage 5 – hot cycles, fill profile

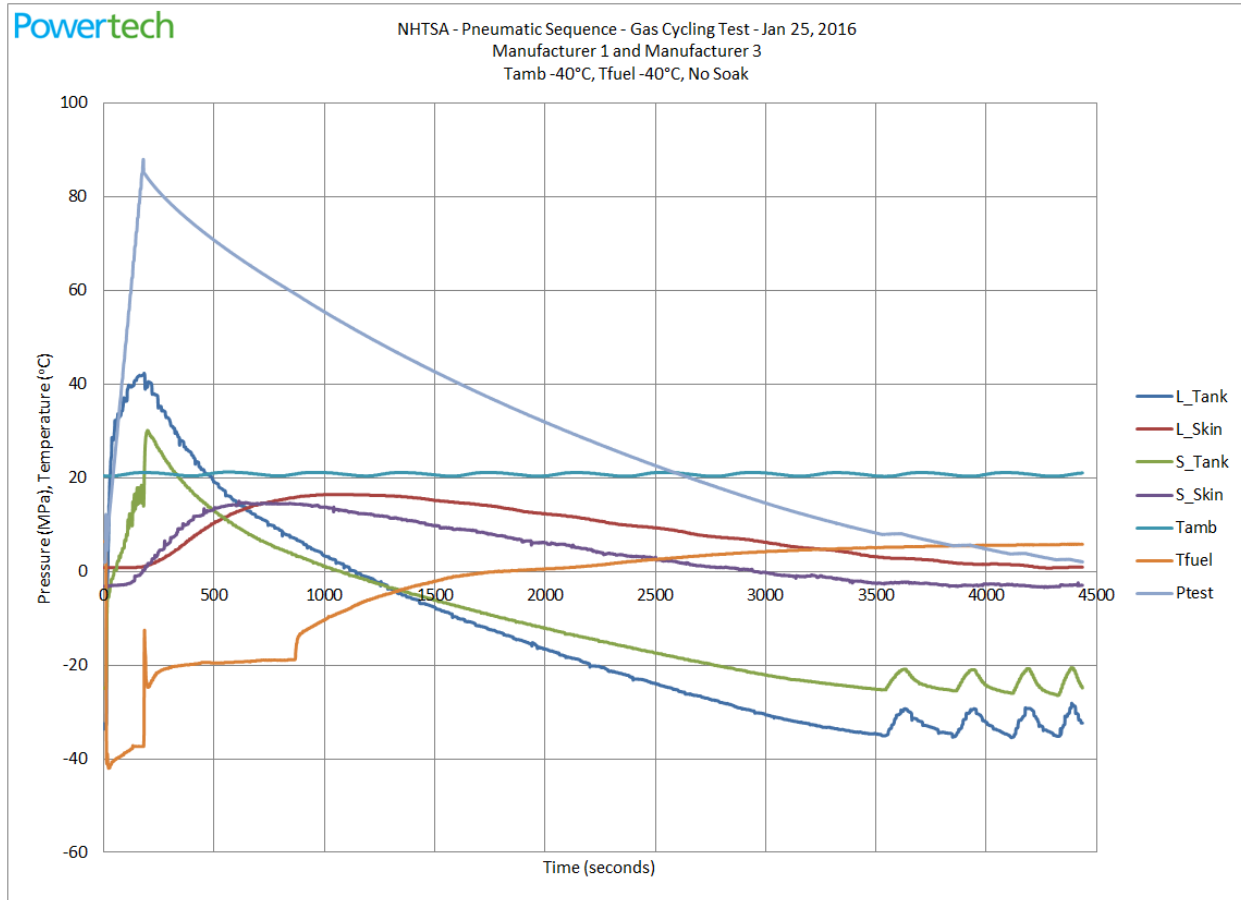
Figure 60. Gas Cycling Test Stage 10 – ambient cycles, full cycle

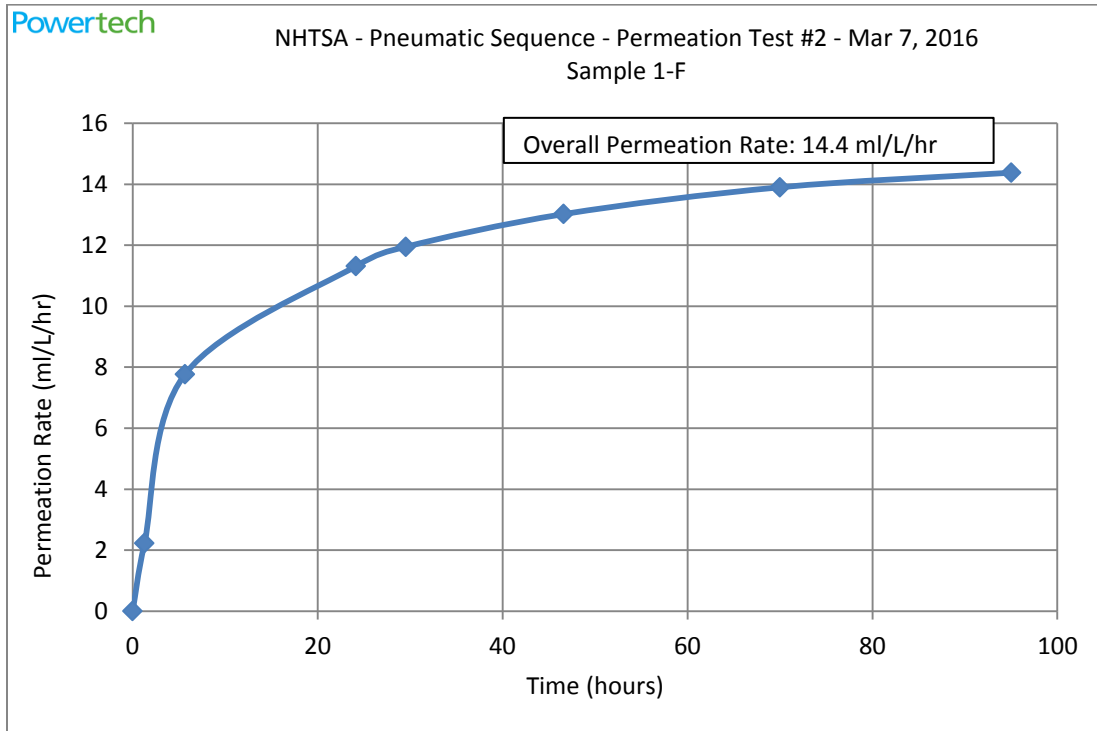
Figure 64. Permeation Test #2, Container 1-F

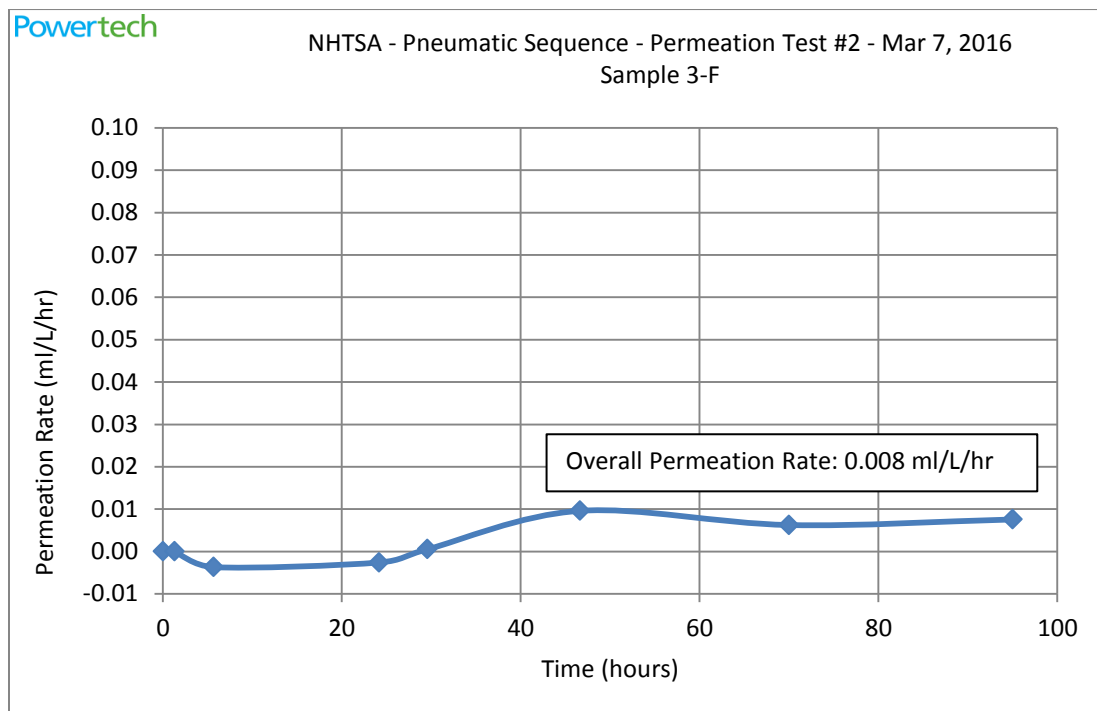
Figure 65. Permeation Test #2, Container 3-F
