**National Highway
Traffic Safety
Administration**

DOT HS 812 789

Stranded Energy Assessment Techniques and Tools

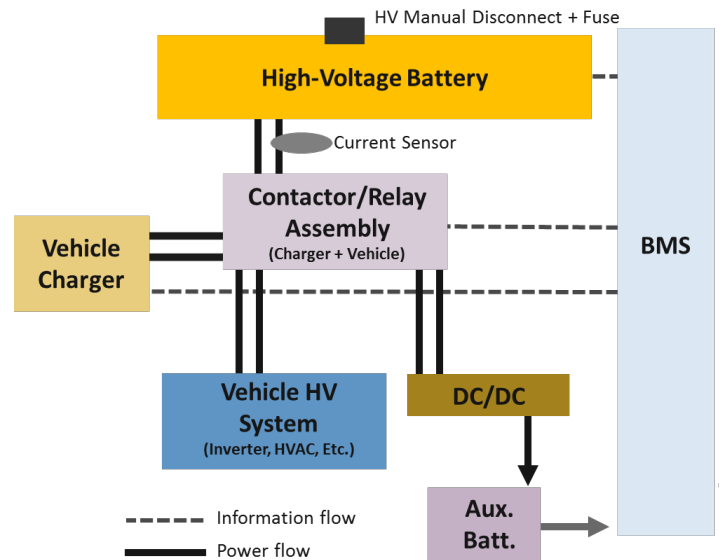
Figure 1: Overview of basic high-voltage system and components

Starting with the high-voltage battery and working outward, a variety of components as well as power and information flow pathways can be observed. The contactor/relay assembly acts as a gateway between the vehicle's high-voltage battery and other on-vehicle high-voltage componentry. The assembly is almost always powered by vehicle 12V power and the contactors close when power is applied. Contactors are open when the vehicle is in an "off" state or if the battery management system (BMS) detects a battery related issue that will also open the contactors, thus removing the battery from the rest of the high-voltage distribution system. The majority of vehicles have a contactor on both the positive and negative leads going to the vehicle system, there are also typically one or more additional contactors used to facilitate a discharge resistor and capacitor in order to reduce the voltage in-rush seen by other components as the contactors are activated. Vehicles with off-board charging capability (PHEVs and BEVs) will typically have an additional set of contactors (at least positive/negative) for usage of the vehicle charging system while retaining battery isolation to the rest of the high-voltage traction system.

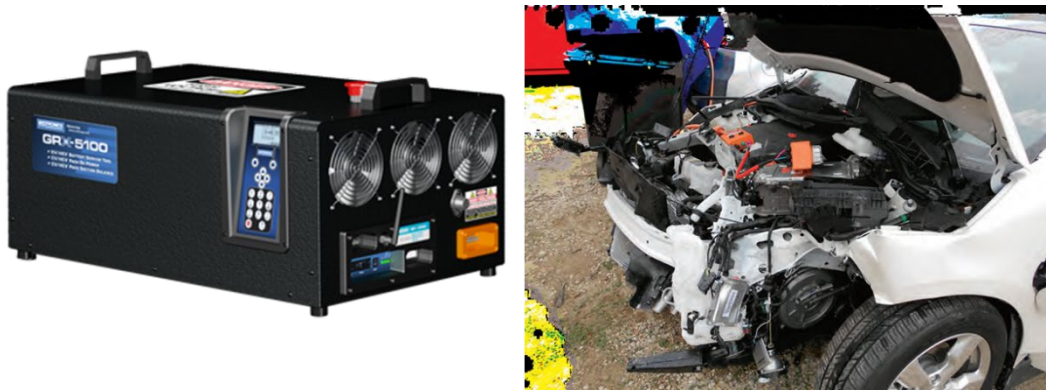
The first tool of significant interest is the Midtronics GRX-5100 EV/HEV Battery Service Tool [4]. The GRX-5100 is used for the majority of GM products including PHEVs such as the Chevrolet Volt and Opel Ampera as well as some other hybrids such as the Buick Regal eAssist. Powered off AC 120V wall power, the service tool can provide up to roughly 3 kW of battery discharge capability and can also be used to charge or discharge individual pack modules if the proper connections are available (battery is removed from the vehicle in the case of the Volt). Figure 12 shows the main discharge/control box for the GRX-5100 (left) as well as the basic connections in use on a damaged vehicle (right). As can be seen on the right side of Figure 12, a typical battery-in-vehicle discharge connects the GRX-5100 to the battery using an adaptor that connects into the main DC cables that enters the vehicle's inverter/converter under hood. The GRX can also discharge a pack external to the vehicle, assumedly connecting to either the main battery terminals or module interconnections using custom adapters specific to a particular vehicle. During operation, the system tracks temperatures and individual cell voltages by interfacing with the vehicle's BMS and related connections.

Figure 12: Midtronics GRX-5100 EV/HEV Battery Service Tool (connected to a vehicle and discharging on right) [4]

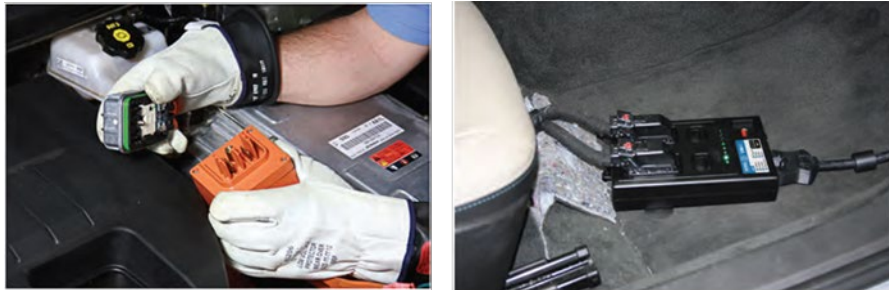
ing for a larger range of vehicles. Moreover, it appears that a fair amount of OEM level information regarding vehicle communications and calculations was provided to facilitate the GRX's communications with a vehicle. These issues highlight the value of working towards a more common diagnostic port and communication structure help to enable fewer custom adapters and reduce the exchange of specific vehicle information.

Figure 13: GRX-5100 example connectors and adaptors [4]

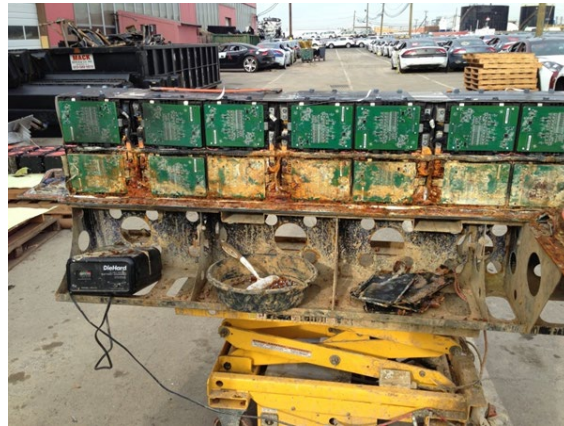
somewhat operational as evidenced by flashing LEDs. Figure 21 through Figure 25 show the variety and degree of damage observed across many of these packs, varying from water intrusion to clear indicators of high-energy discharge. As with the Volt photos, many of the damaged packs show significant BMS board and connector degradation while showing no issues with the individual cells. This again suggests that many of these failures are related to system-level loss of isolation as opposed to cell-initiated failure.

Figure 21: Water Intrusion of the entire pack

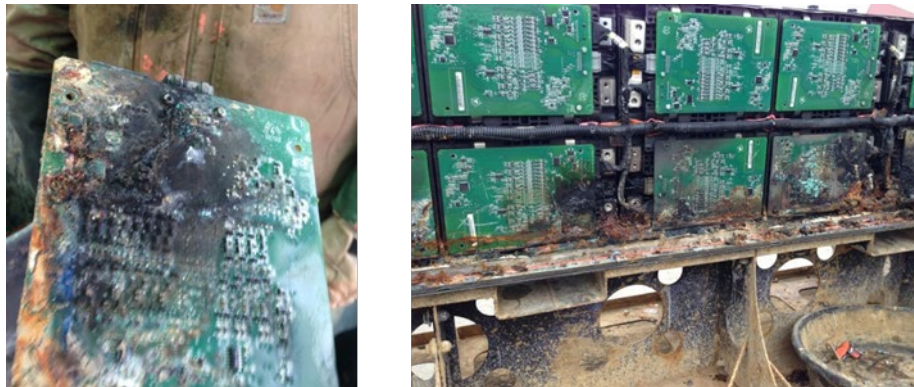
Figure 22: BMS damage and shorting

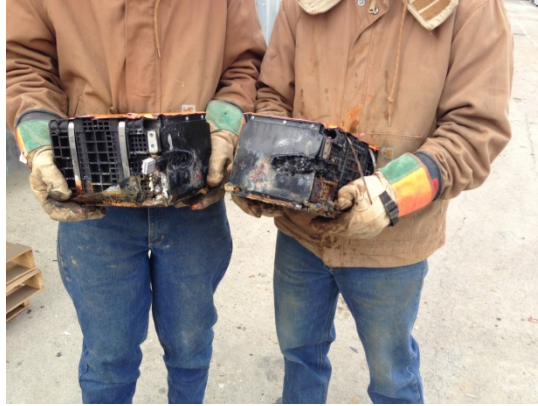
Figure 23: Module enclosure damage

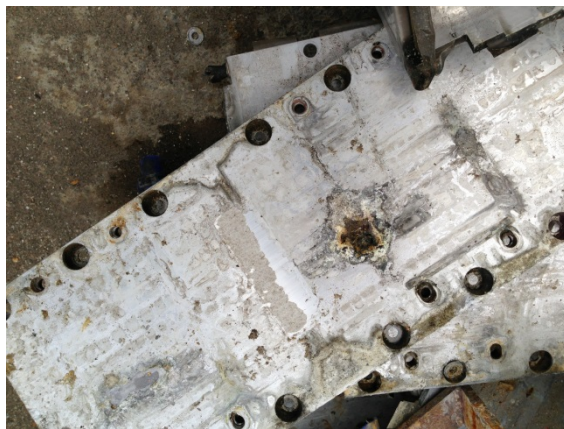
Figure 24: Evidence of arcing/aggressive discharge

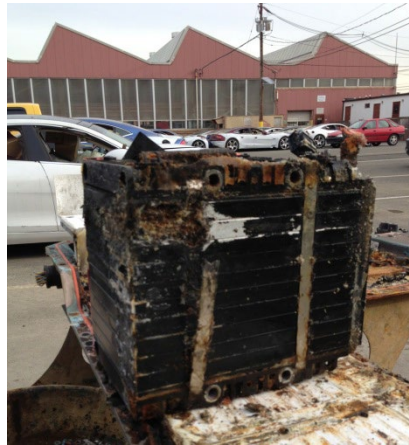
Figure 25: Evidence of actual individual cell damage

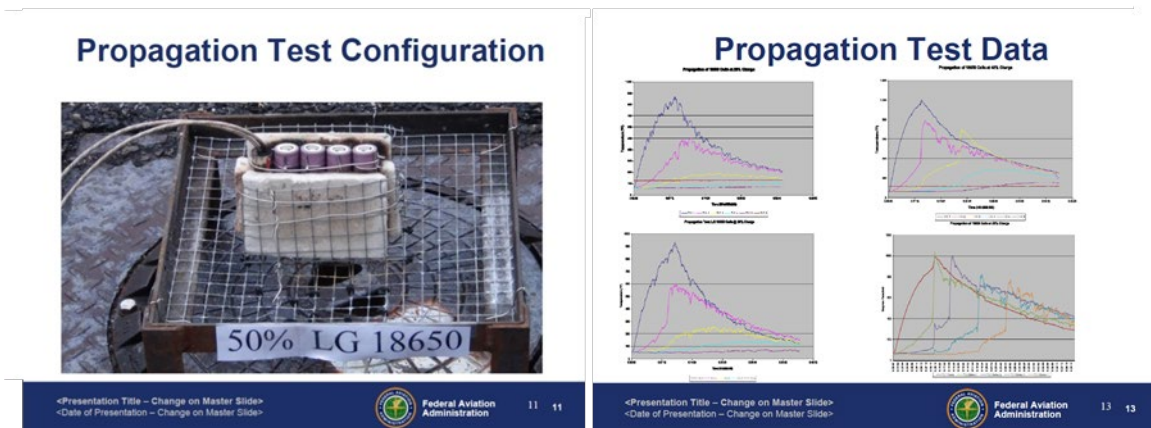
Given their relatively earlier acceptance into commercial goods and the challenges associated with air-shipment of Li-ion batteries [10], regulations and research related to the air shipment of Li-ion batteries was selected as a possible avenue of research for information regarding the relationships between the severity of thermal events and battery SOC. As would be expected with such an important topic, the Federal Aviation Administration (FAA) has completed several research experiments regarding pack thermal response relative to SOC. More specifically, the work of Webster[13] provides some critical insight as well as data regarding both the cell level thermal response and pack propagation aspects of Li-ion batteries relative to SOC. The inclusion of pack propagation information is particularly insightful and relevant to this project since the majority of flammability and safety research focuses on individual cell response relative to SOC. In the pack propagation portion of these experiments, four 18650 format Li-ion cells were wired together to form a module and a 100W cartridge heater was placed next to the first cell in order to provide the heat for the runaway experiment. Tests were run at 100 percent, 50 percent, 40 percent, 30 percent, and 20 percent SOC and thermocouples were used to record individual cell temperatures for each of the four cells in the string as well as the cartridge heater. Figure 28, created with slides compiled from an FAA presentation [13], shows the experimental setup (left) and example results for this work (right).

Figure 28: FAA testing/presentation of Li-ion battery thermal propagation versus state-of-charge (SOC) [9]

As discussed in the FAA presentation and summarized here, several behaviors were seen across the range of SOC's tested during the pack propagation study. As would be expected from the general trends of more aggressive thermal behavior at elevated SOC levels, the first cell in the 100 percent SOC case heated very rapidly and exploded with a peak observed temperature of 1030°F observed at Cell 1. Following the explosion, Cell 1 rapidly cooled and minimal heat was transferred to the other cells within the module, resulting in minimally elevated temperatures seen across Cells 2-4 (~200°F at Cell 2). For the 50

percent SOC test case, shown in the lower right sub-figure of Figure 28, all cells see elevated temperatures (Cell 1 max = 1044°F) and all cells are in fact consumed due to thermal propagation through the module. It is assumed that since the 50 percent SOC case did not exhibit the rapid cooling observed in the 100 percent SOC case following the explosion, more heat flowed to the remaining cells culminating in the consumption of the entire module. At 40 percent SOC Cells 1 and 2 are consumed due to thermal exposure (Cell 1) and propagation (Cell 2), while Cells 3 and 4 remain relatively stable. Testing at 30 percent and below shows minimal to no thermal runaway propagation. Although Cell 1 vented for both low SOC cases (30% and 20%), the peak observed Cell 1 temperature was roughly half compared to the 100 percent and 50 percent testing, again supporting the idea that, on an individual cell level, lowered SOC levels reduce the severity of a thermal event should one occur. More importantly, this work provides evidence that a SOC level below 50 percent, on the order of perhaps 30 percent or lower, may offer additional protections in terms of propagation of thermal runaway within a module and pack.

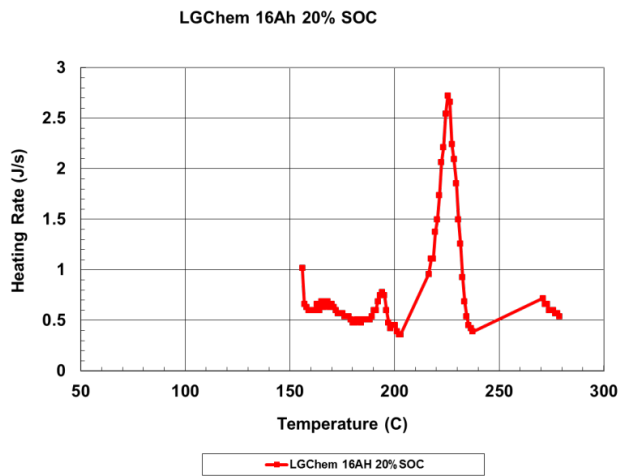
Figure 31 below shows the exothermic heating rate of the thermal decomposition of cells at 20 percent SOC. This shows most of the energy of the event occurs within a single peak with an onset of 216 °C. Maximum peak heating rates of 2.7-3.8 W were observed, with total enthalpies of 38.7-40.5 kJ.

Figure 31: ARC data of cell at 20 percent SOC

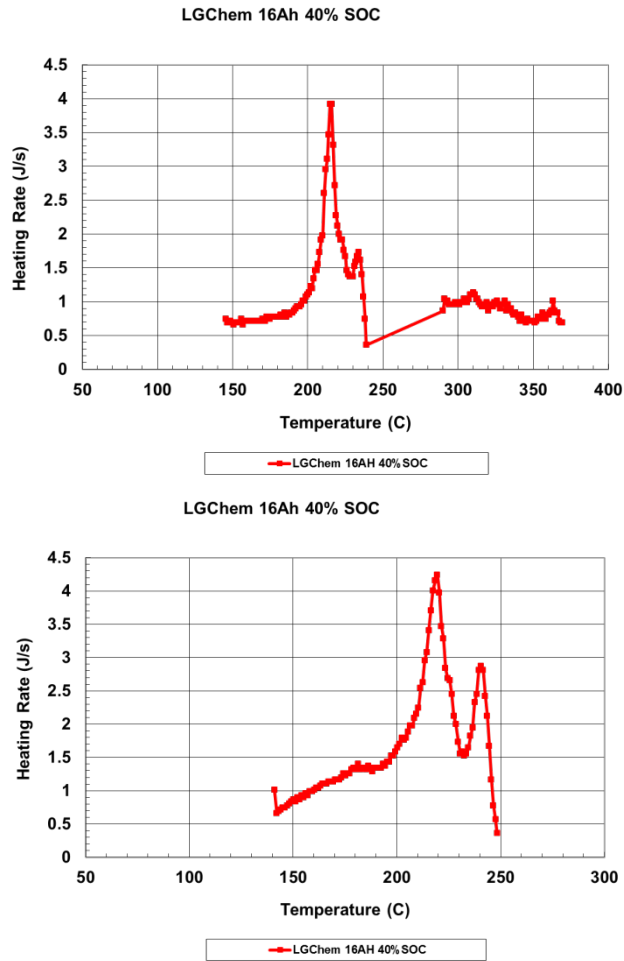
Figure 32 shows the heating rate data collected at 40 percent SOC. The primary runaway shows an onset of 190 to 192 °C, with peak heating rates of 3.9 to 4.3 W. This also shows a second peak forming as part of the runaway reaction. This two peak runaway reaction is a common behavior for spinel-based chemistries. Enthalpies of 90 to 116 kJ were observed during the runaway reaction.

Figure 32 ARC data of cell at 40 percent SOC

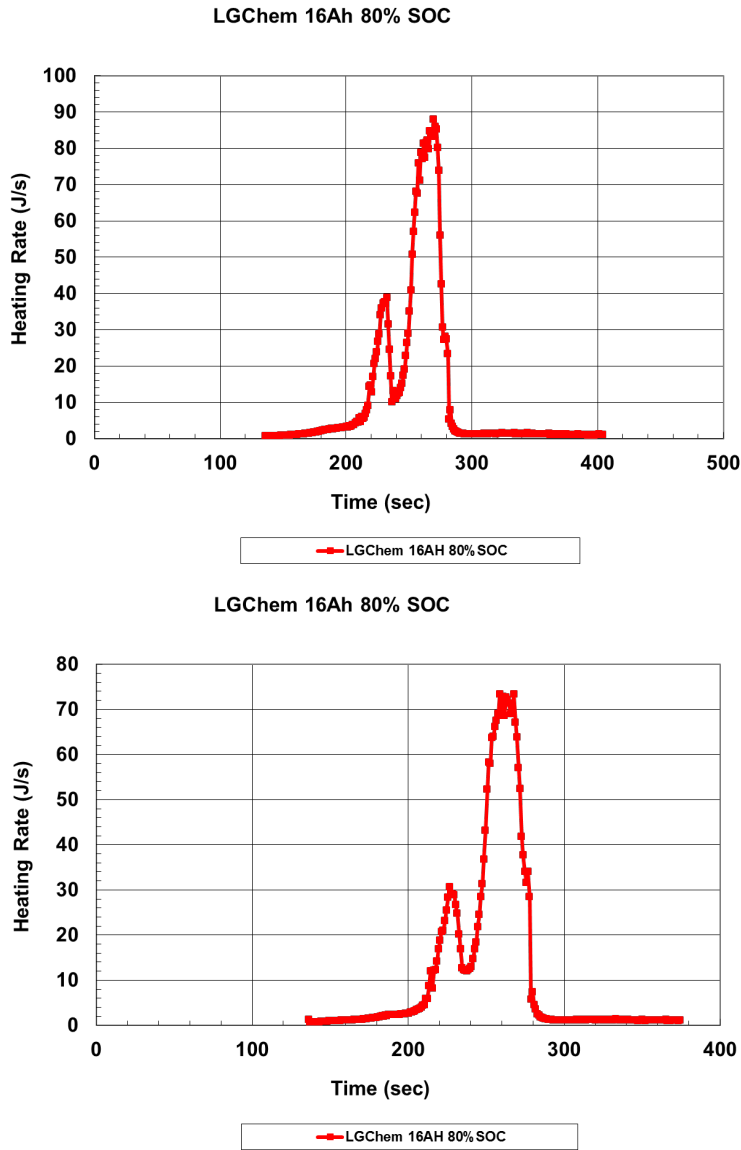
Figure 34 below shows the heating rate data collected on cells at 80 percent SOC. An onset of 188 to 193 °C was observed, with peak heating rates of 73 to 88 W. This continues the trend of increasing prominence of the second peak, also the peak heating rates have begun to significantly increase at this SOC. Total runaway enthalpies of 140 to 154 kJ were observed.

Figure 34: ARC data of cell at 80 percent SOC

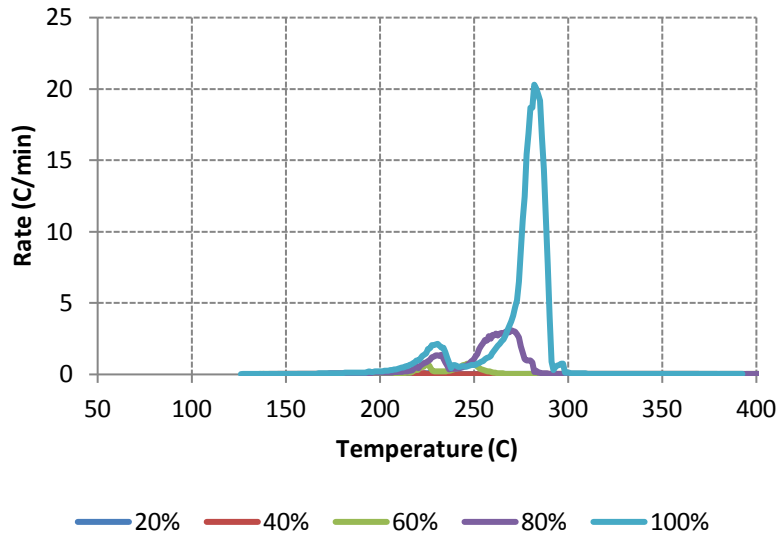
Figure 36: ARC exothermic rate data comparing 20 to 100 percent SOC.

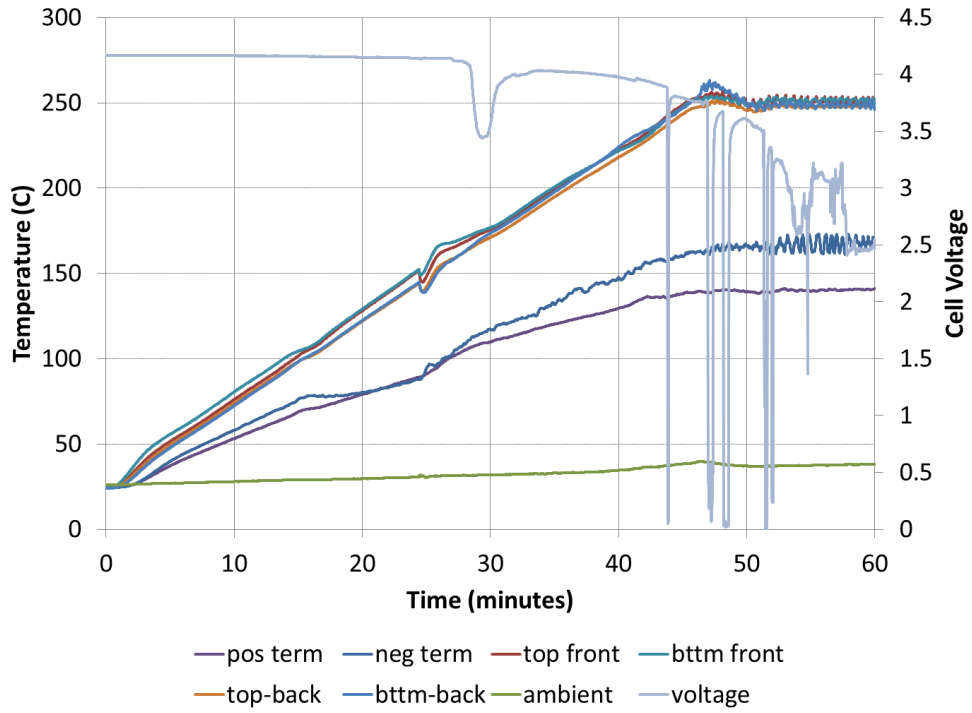
Figure 40: Thermal ramp test performed at 100 percent SOC showing a venting event, and some limited self-heating at 250 C, but no thermal runaway event.

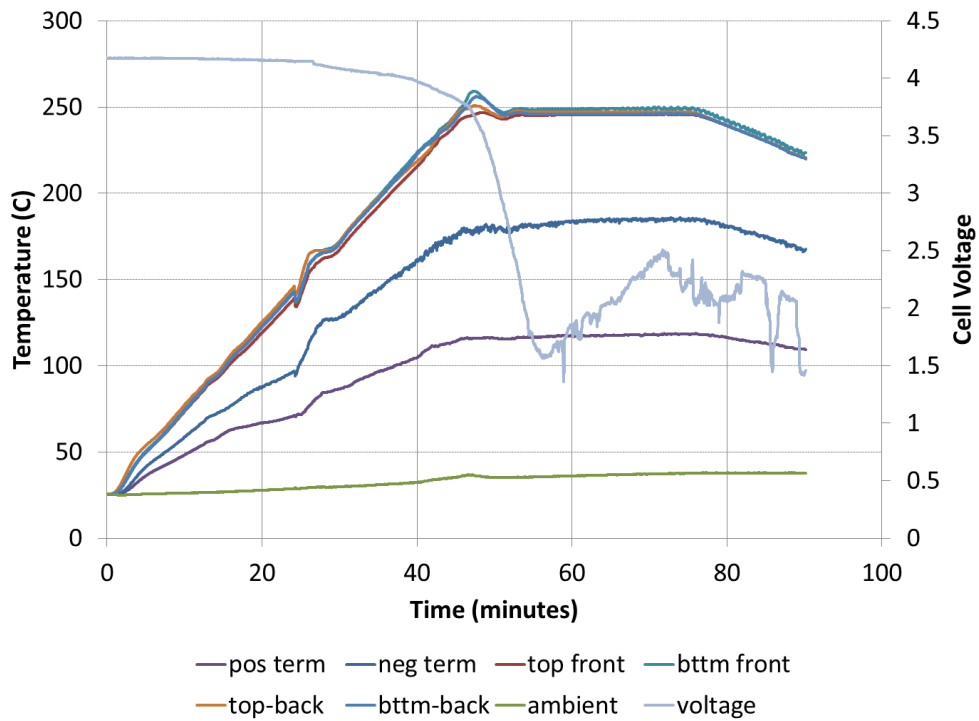
Figure 41: Thermal ramp test performed at 100 percent SOC, showing again a small self-heating event at 250 C, but no true thermal runaway.

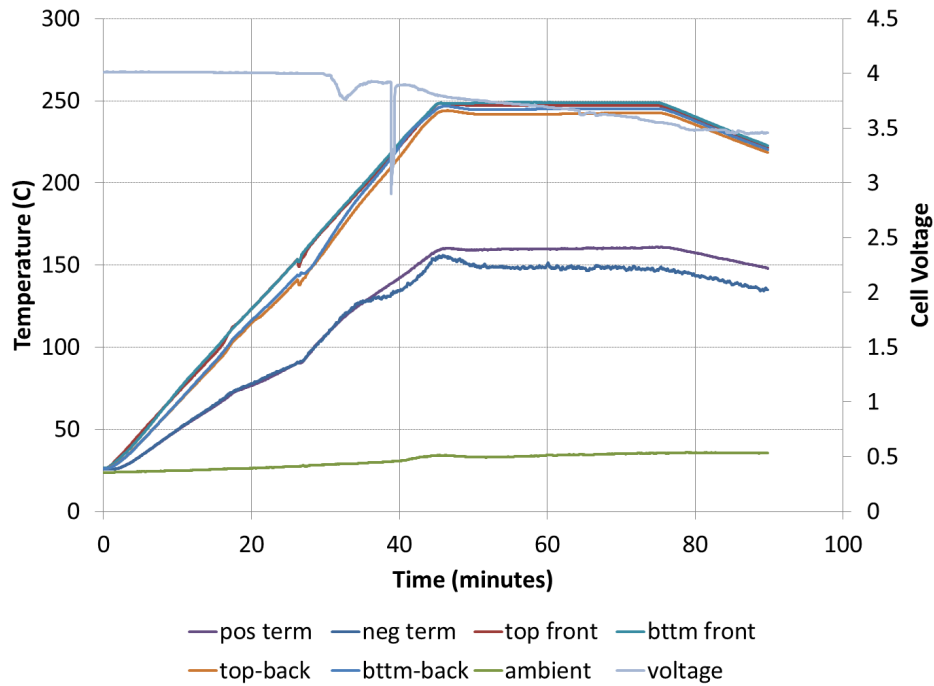
Figure 42: Thermal ramp test performed at 80 percent SOC

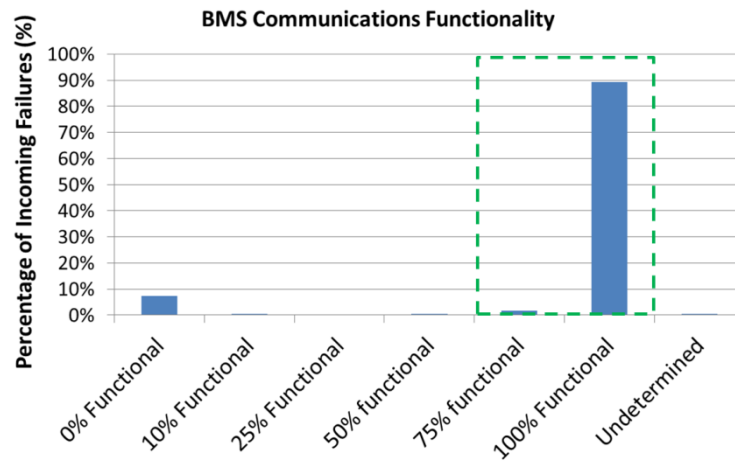
Figure 51: BMS functionality distribution of damaged packs in study

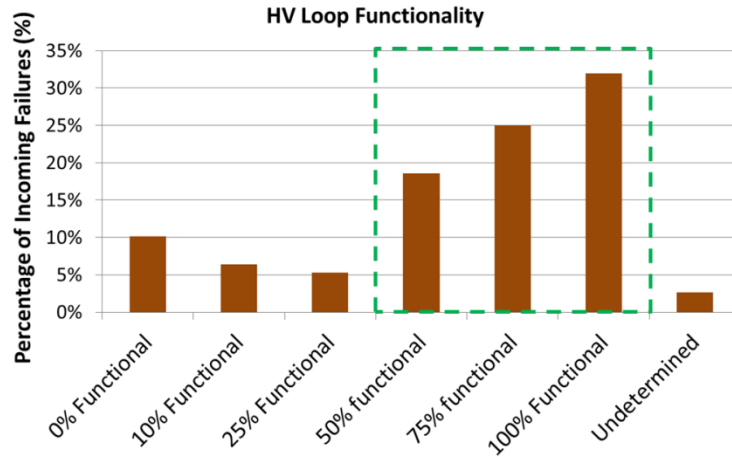
Figure 52: High-voltage loop functionality distribution of damaged packs in study

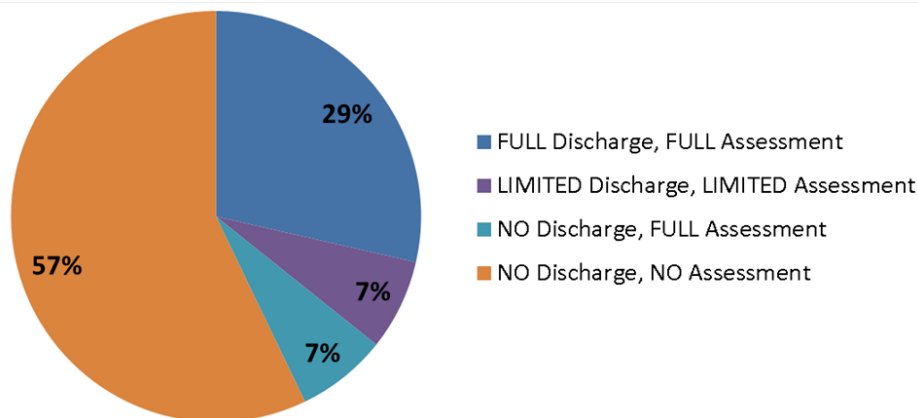
Figure 54: Discharge and assessment capability for damages packs experiencing water intrusion

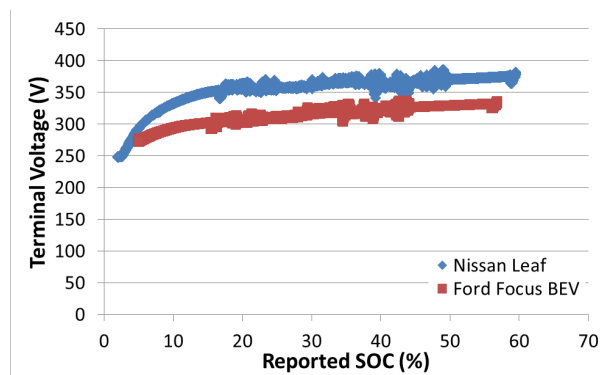
Figure 55: Terminal voltage versus reported SOC for two select BEVs

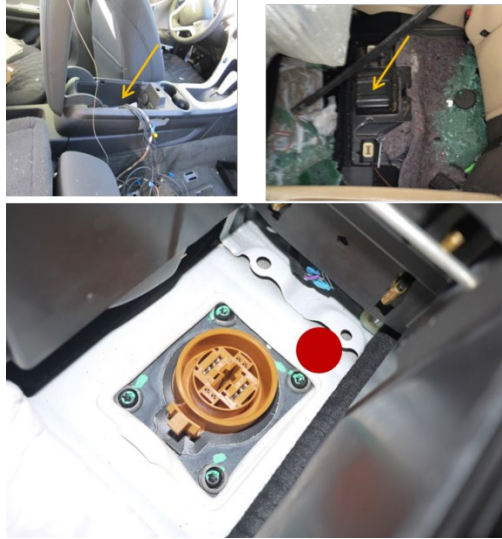
Figure 57: Diagnostic Port Location Suggestions
 Top left: within center console, top right: under rear seat (with metal cover), bottom: colocation with MSD

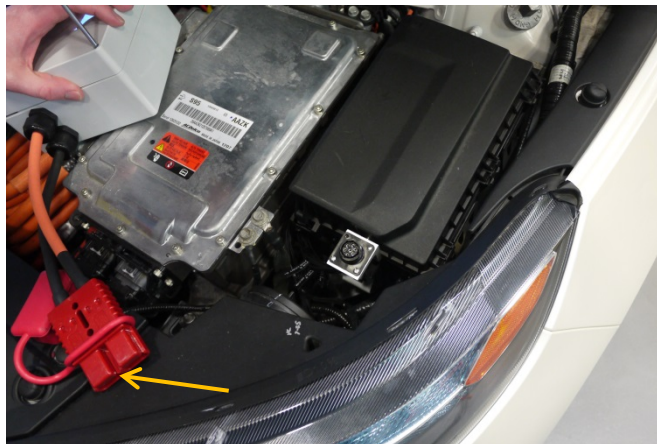
Figure 59: Developed prototype connector for high-voltage terminal access

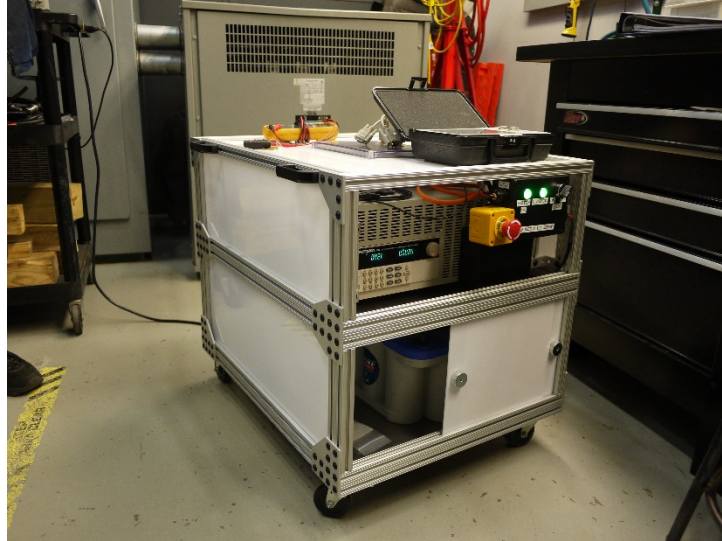
Figure 64: Discharge Cart and Component Locations

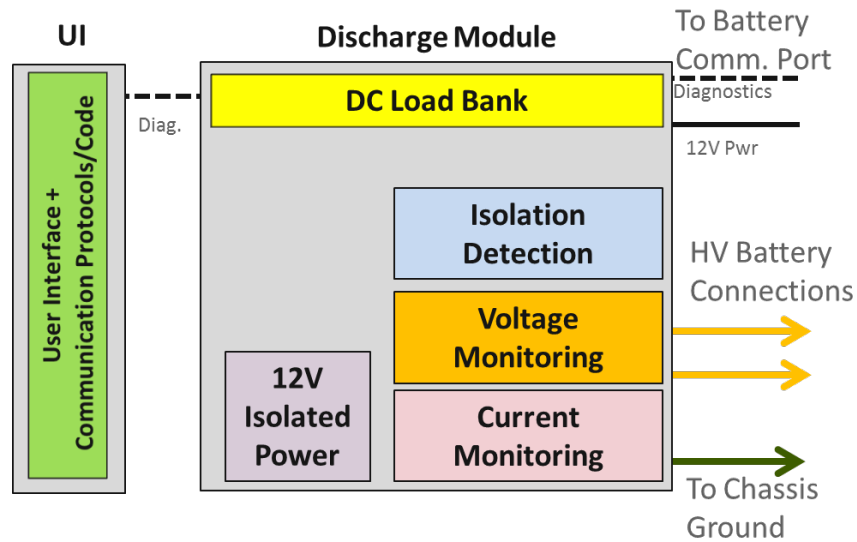
Figure 65: Overview of Discharge and Assessment Tool Components

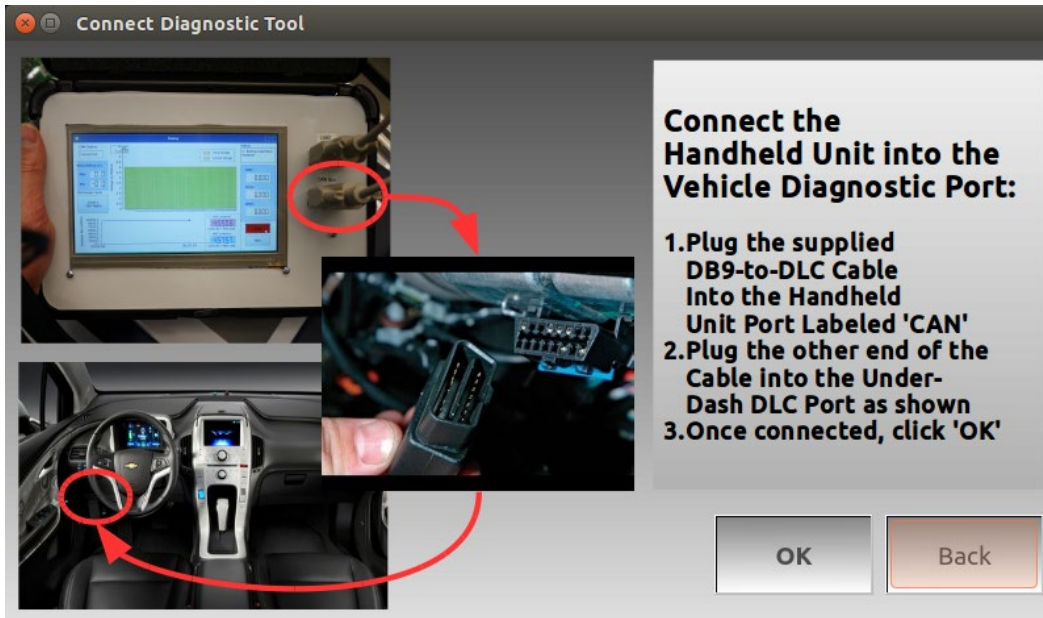
Figure 68: Screenshot – Connection instructions for DLC-based vehicle BMS assessment

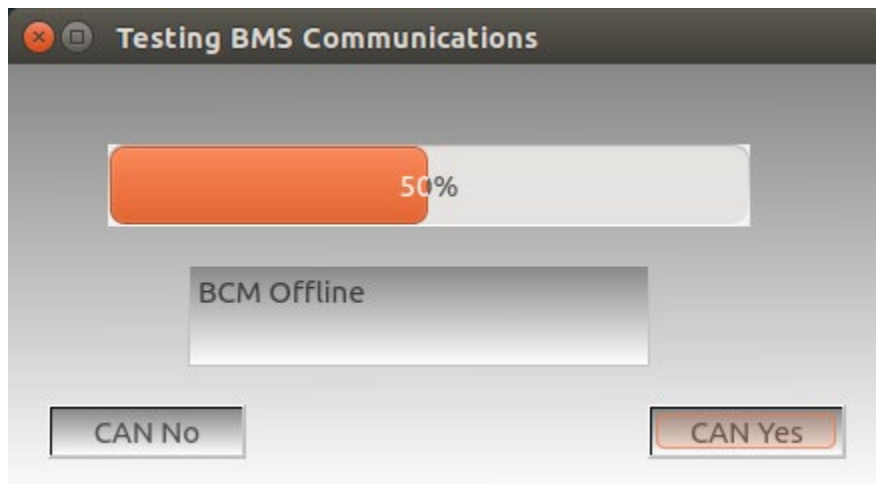
Figure 69: Screenshot - CAN Communications assessment progress screen

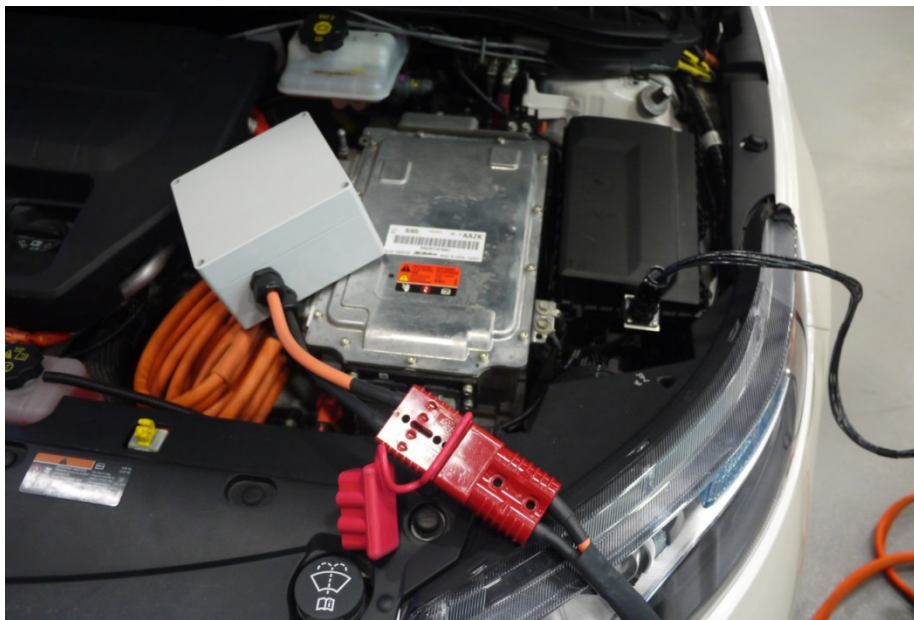
Figure 71: High-voltage and diagnostic interface port connections

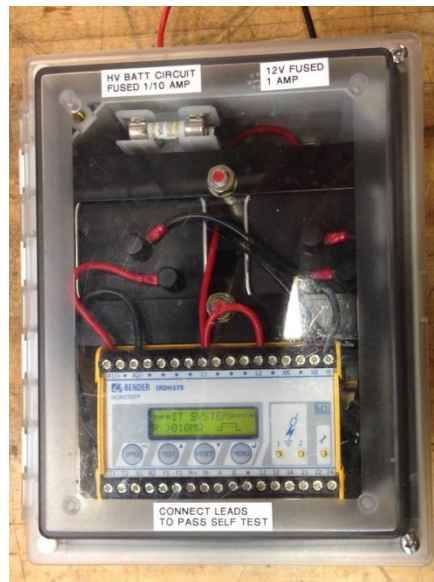
Figure 78: Offline isolation monitoring prototype tool

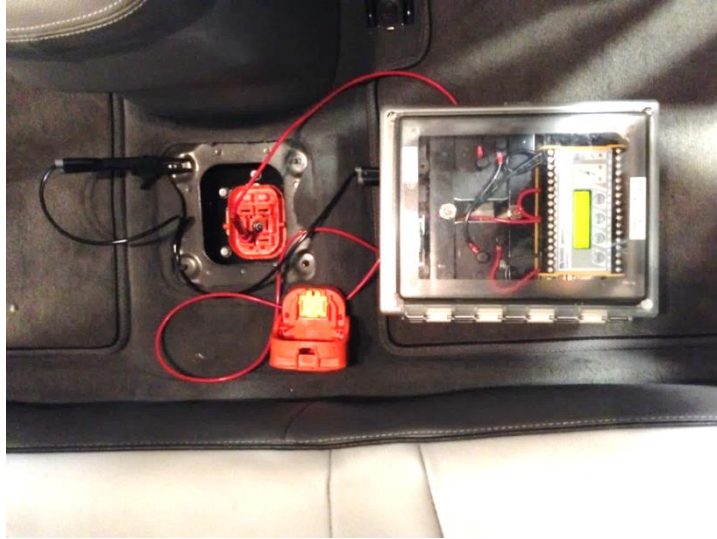
Figure 79: Tool installation in a BEV to evaluate isolation of half pack via removed MSD
